**ARBORIST REPORT FOR BRICKYARD RIDGE
18331 – 154TH AVE NE & 15215 NE WOODINVILLE-DUVALL ROAD
WOODINVILLE, WA**

May 6, 2013
Tree Density Calculation Updated 9-17-13

BRICKYARD RIDGE TREE PRESERVATION PLAN

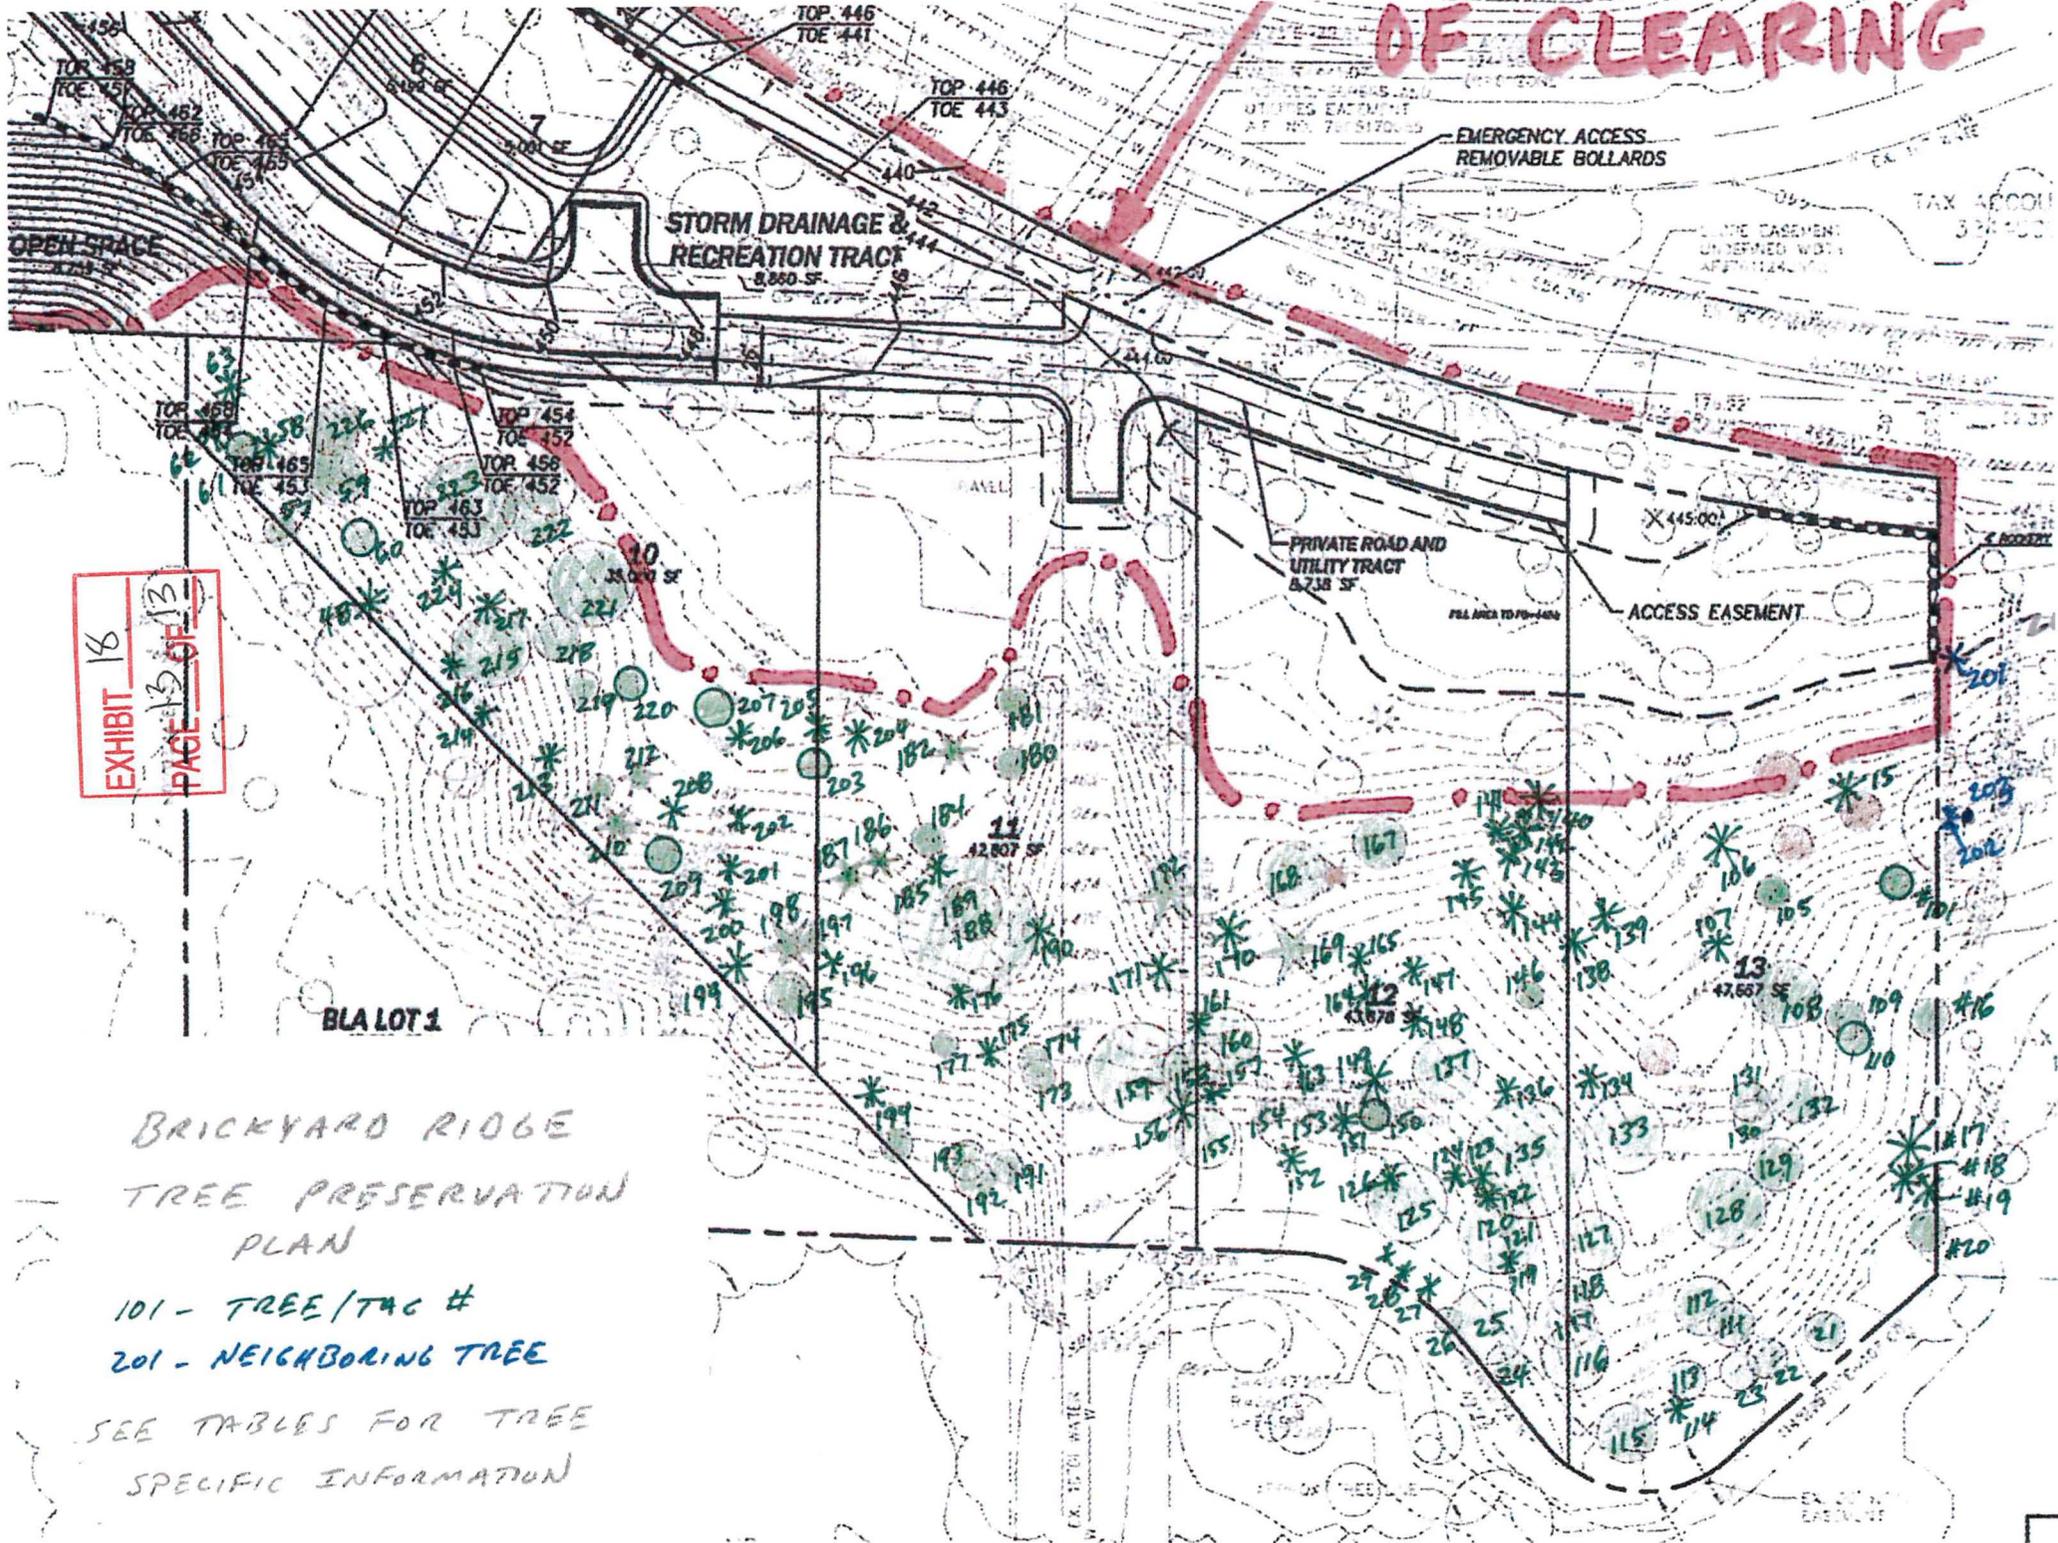
The western hemlock is in good condition for the most part. Trees have developed good structure. Foliage appears healthy and of good color. *Annosus* Root Disease was identified on trees #144 and #145, near the center of the tree preservation area, close to the clearing limit. A few hemlock trees have been wind-thrown above this area in the past.

Impacts to neighboring trees are not anticipated to be significant. Tree #201 on the east property line next to the proposed development area is a small 15” DBH western hemlock. It appears to be located very close to the property line. No concerning issues were noted on the west property line.

For neighboring tree #201, a 6' zone of no disturbance to the west is recommended to preserve structural stability.
