City of Woodinville  
**Old Woodinville School House  
Feasibility/Renovation Study**

**Council Report**  
January 27, 2011

Existing Conditions Assessment  
October 23, 2009

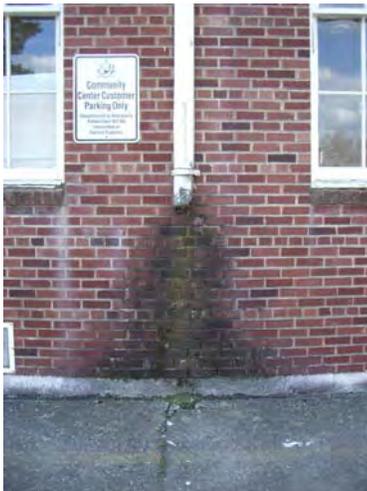
Fig C) Stain on brick at east downspout

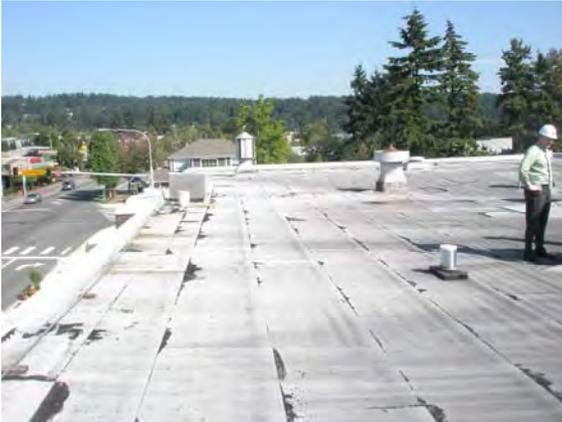
Fig D) Roof looking east

The existing roof membrane will be removed to allow installation of new wood sheathing (shear diaphragm). The building will be reroofed with a torch-down membrane. The existing parapet cap will be salvaged and reinstalled. Scuppers and downspouts will be cleaned and repainted, or replaced where missing or damaged beyond repair.

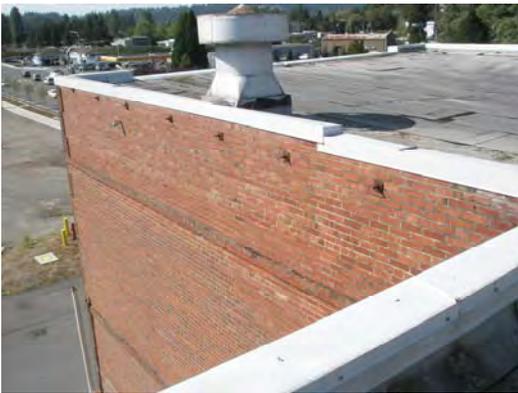
Fig E) Parapet/coping at south/west corner

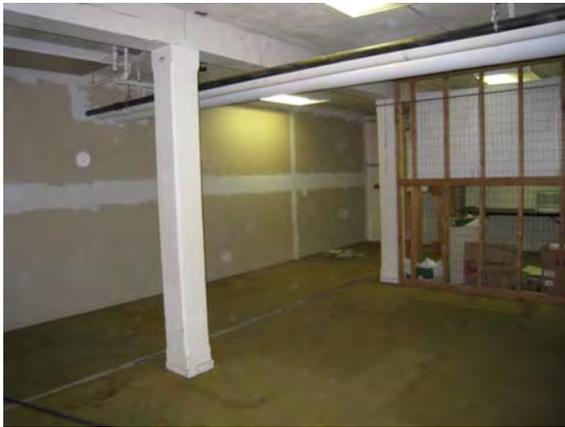
Fig I) Basement modified with GWB and wire mesh storage area

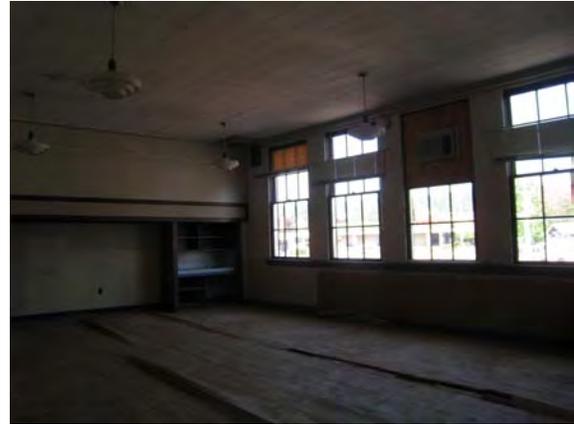
Floor finishes in the basement include linoleum, wood on 2" sleepers and direct-glue carpet. The linoleum floors and carpet are in very poor condition, with evidence of water staining. The raised wood floor is in fair condition, with some bowing visible.

Fig K) Classroom with buckling wood floor

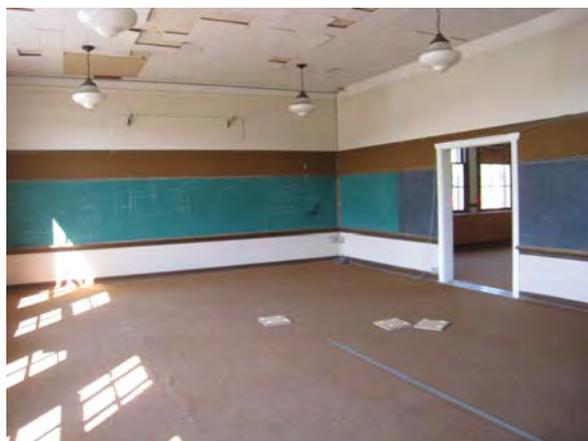
Fig L) Classroom with damaged ceiling tiles

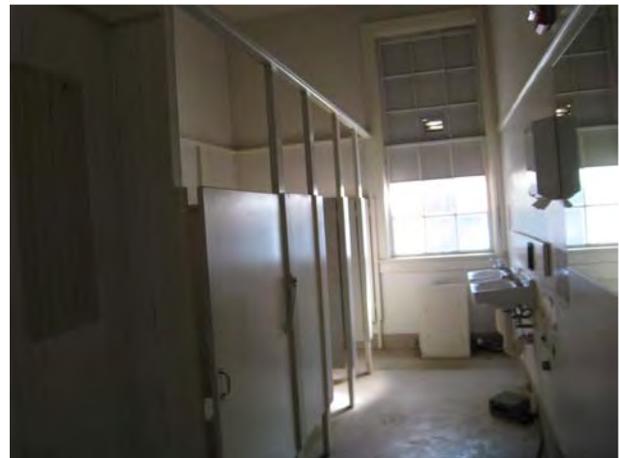
The bathrooms have original wood stall partitions and doors, with wall-hung porcelain sinks and toilets and urinals. The layout and dimensions of the bathrooms do not meet current code standards for ADA accessibility. Floors appear to be linoleum or some type of waterproof liquid-applied coating and are in fair condition. There are several classrooms and accessory rooms with sinks. Hallway drinking fountains have been removed.

Fig N) Typical bathroom

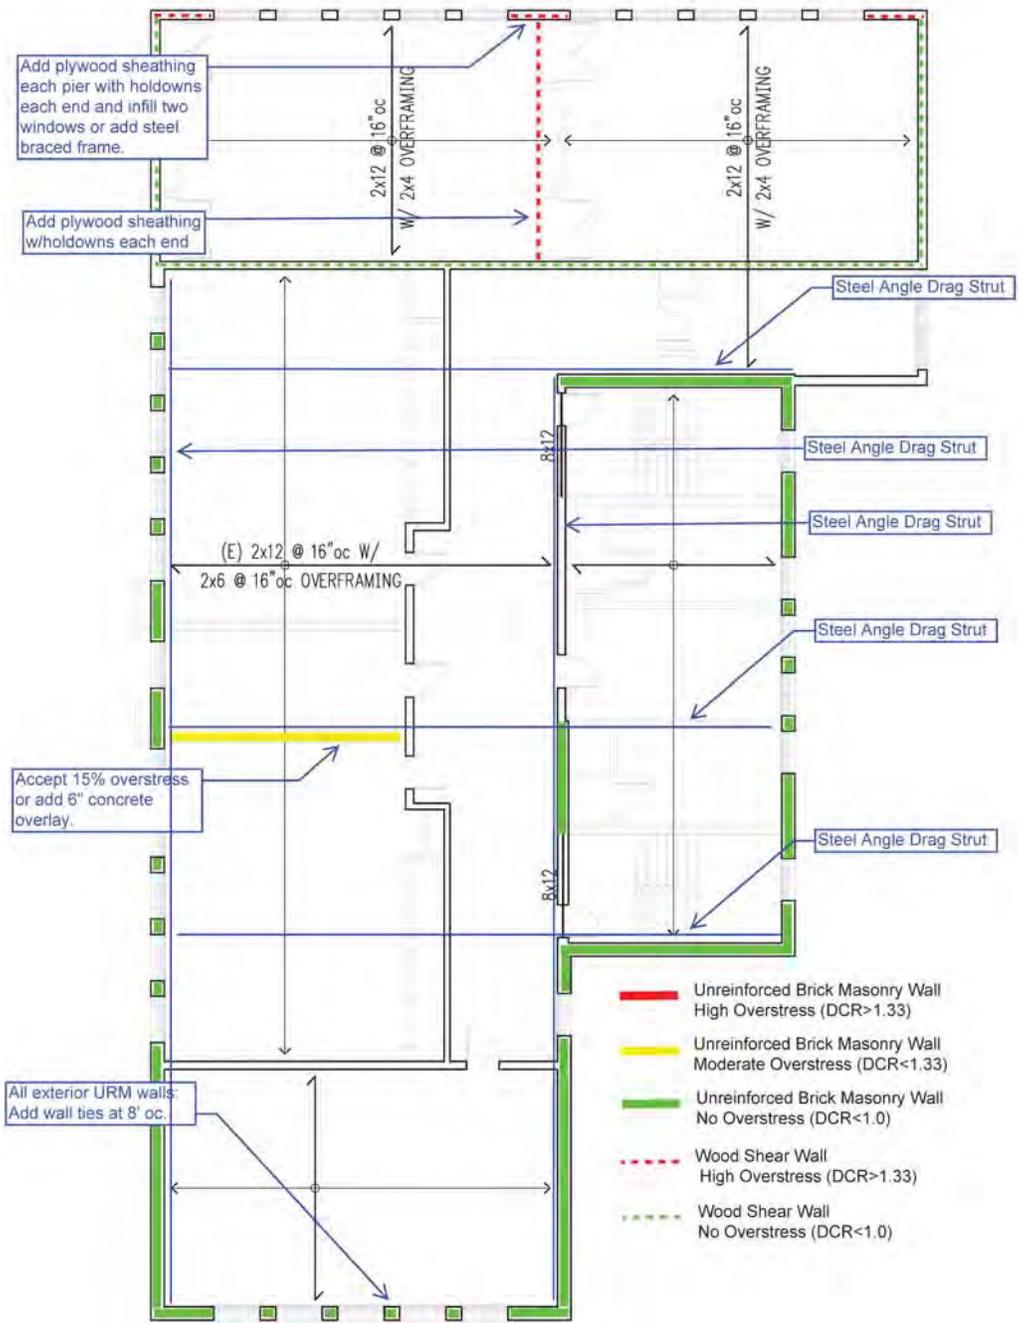
*Figure 1 – Roof Evaluation and Rehabilitation*

*Diaphragms Findings:* We found that the roof diaphragm adjacent to the north, south, and center walls were overstressed by 90%. Diaphragm chords consist of double top plate and were found adequate.

*Recommendations:* Overlay the existing roof sheathing with ½ plywood nailed at 6" on-center a distance of 8' from each wall indicated above.
