International Forestry

**ARBORIST REPORT
FOR
15801/15701 Woodinville-Redmond Road
Woodinville, WA**

January 10th, 2013

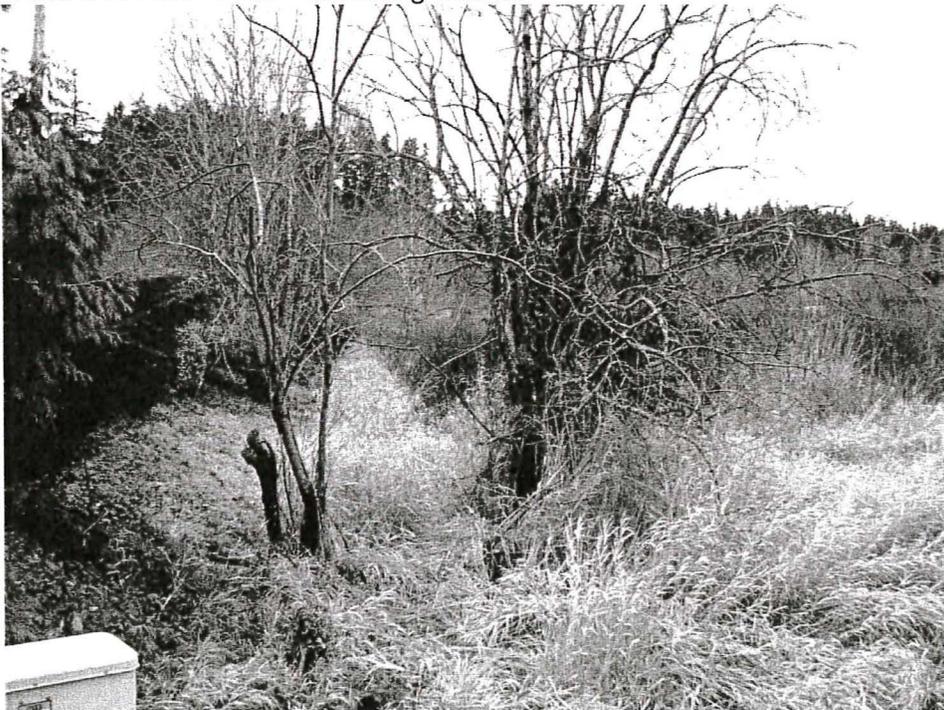
The two willow trees at the front of the property (#101 and #102) are in poor condition. This is evident by dead and broken tops. Both of these are in ultimate decline. The other willow cluster (#105) is younger and in fairly good condition.

Trees #101 and #102 – declining willows

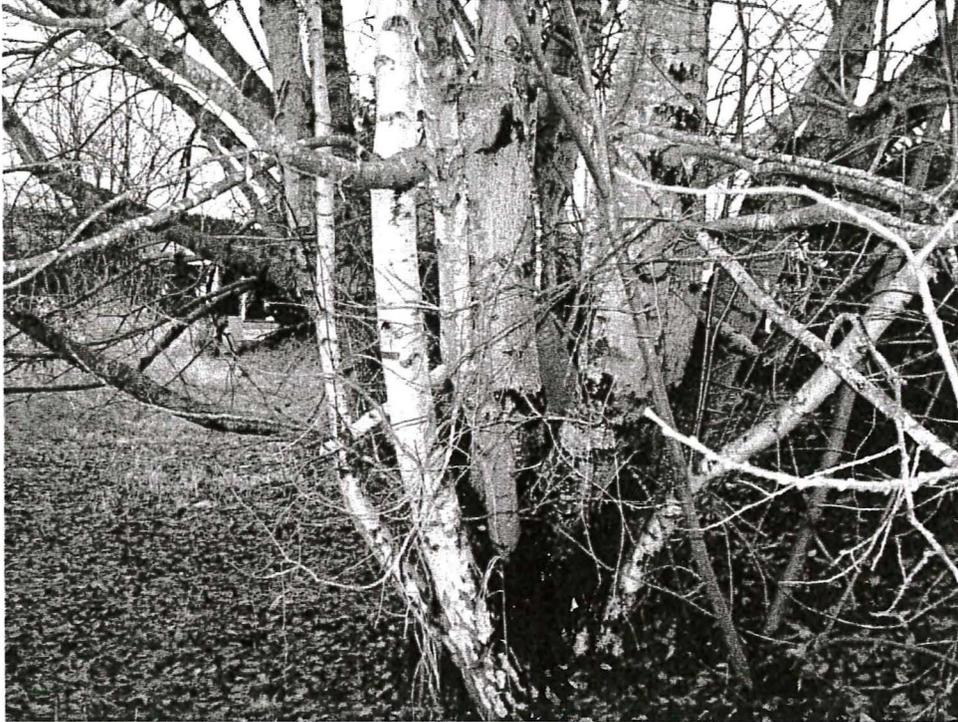
#105 & #106, willow cluster and birch volunteers

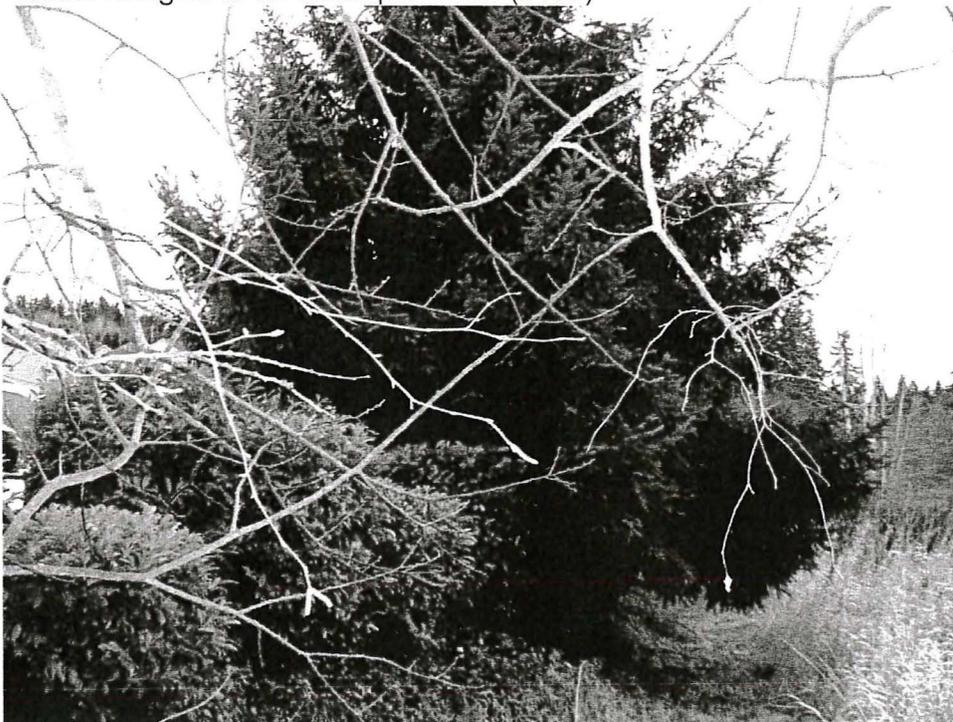
The trees planted on the south perimeter are comprised of eight Douglas-fir, eight clumps of vine maple, and one arborvitae species. The Douglas-firs range in diameters of between 9” and 13”, with total heights of 31’ to 38’. These are approximately 14 years of age. All appear to be healthy and in good condition. The vine maples have stems of 1” to 2” and are made up of clumps of multiple stems. Most appear to be fairly healthy.

Planted Douglas-fir on south perimeter (#107)

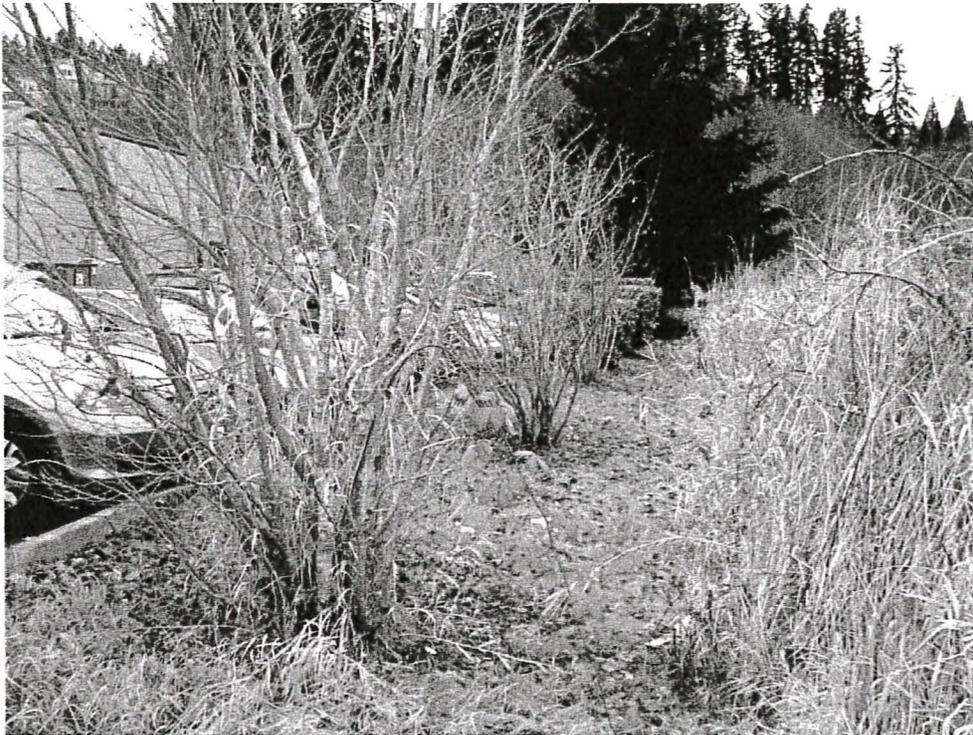
Planted vine maple and Douglas-fir on south perimeter

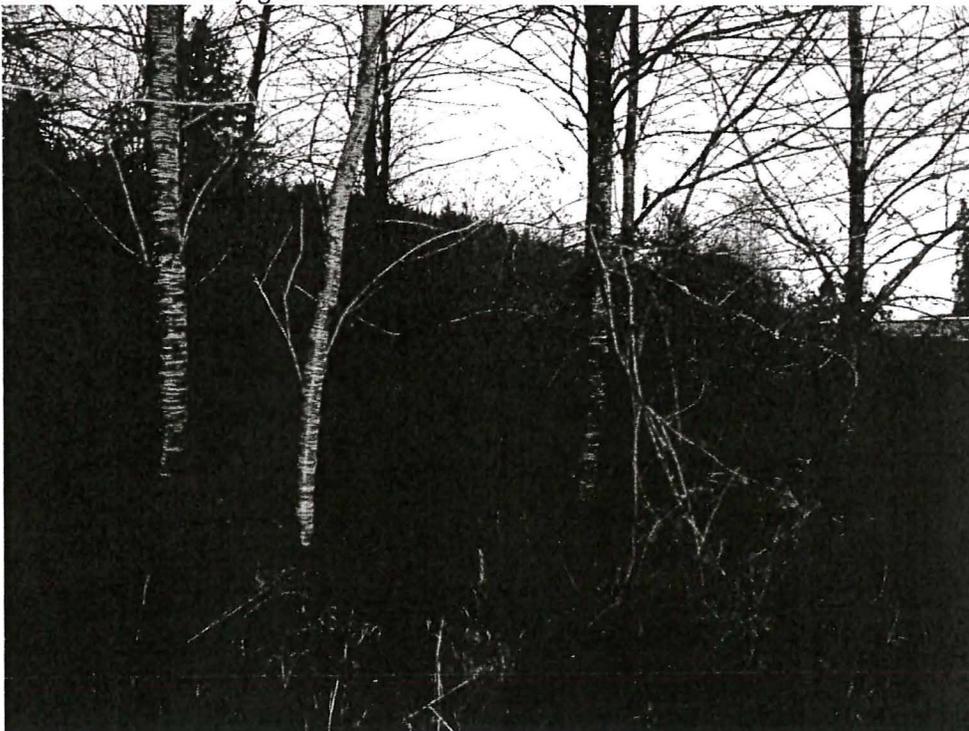
The majority of bitter cherry trees in the southwest corner of the property are non-significant, with diameters ranging between 2” and 5”. These are young specimens which have developed from seed from adjacent mature species in the railway easement. Most appear to be in fairly good condition.

Part of bitter cherry grove in southwest corner

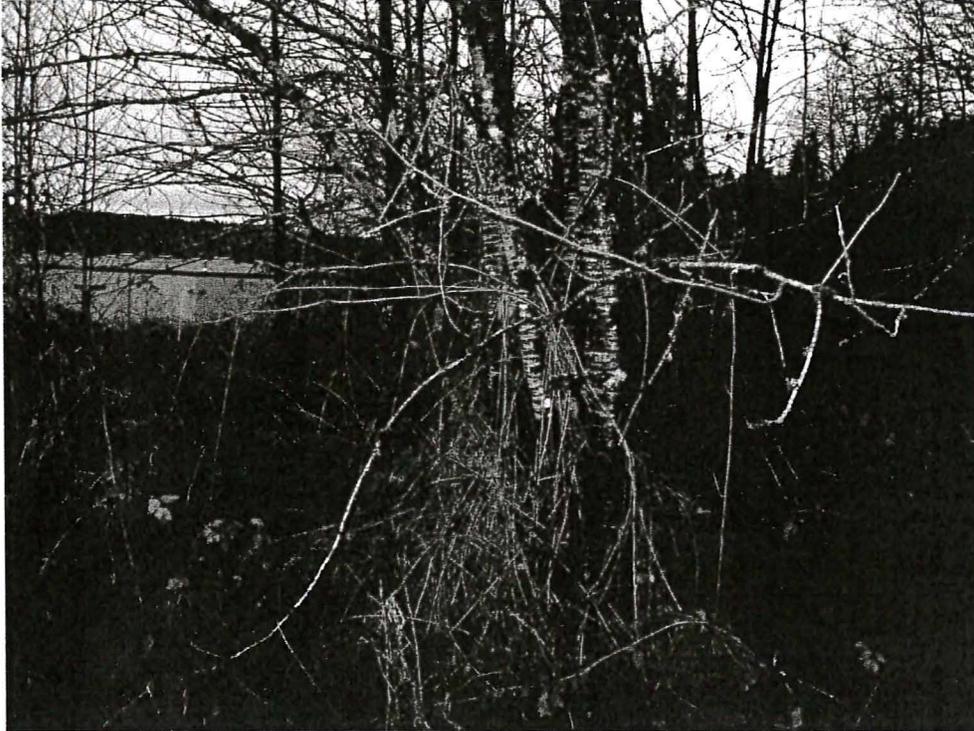
Part of bitter cherry grove in southwest corner

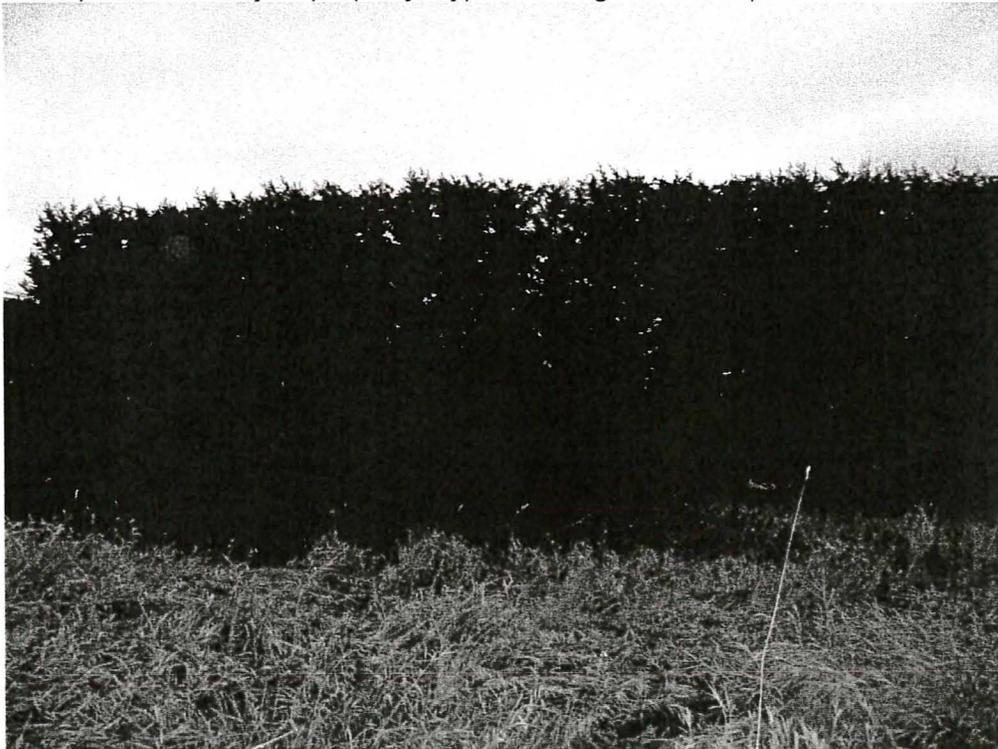
North portion of subject property, cypress hedge on north perimeter

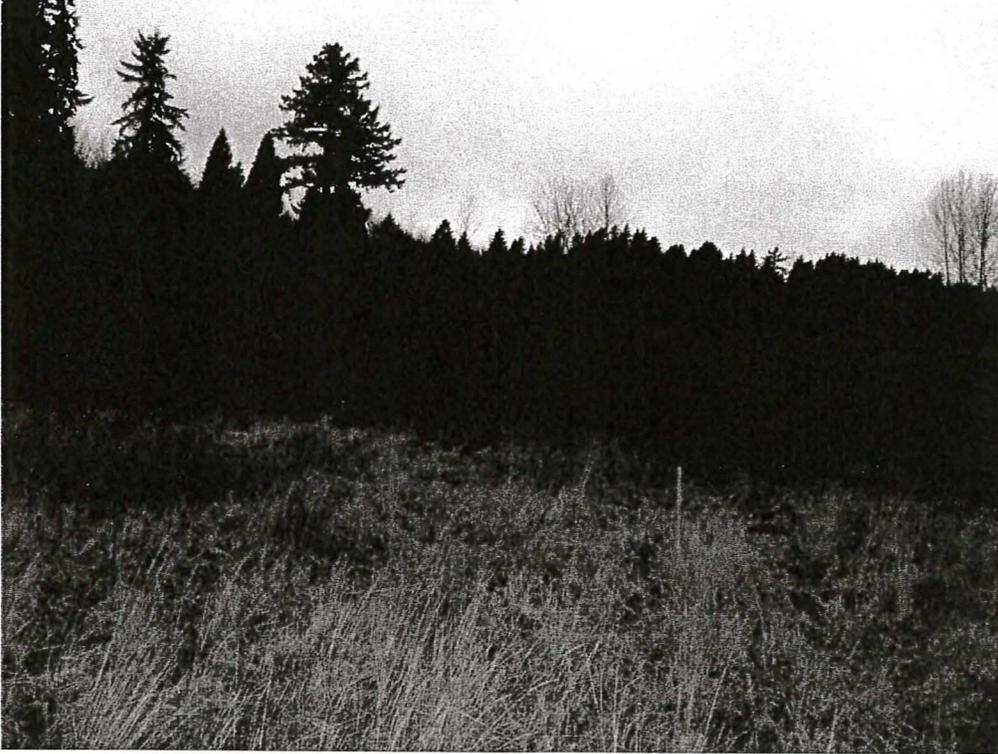
Northwest portion, Himalayan blackberry infestation
