February 3, 2014

Supplemental Slope Stability Letter  
Brickyard Ridge Residential Development  
Woodinville, Washington  
RN File No. 2800-001A

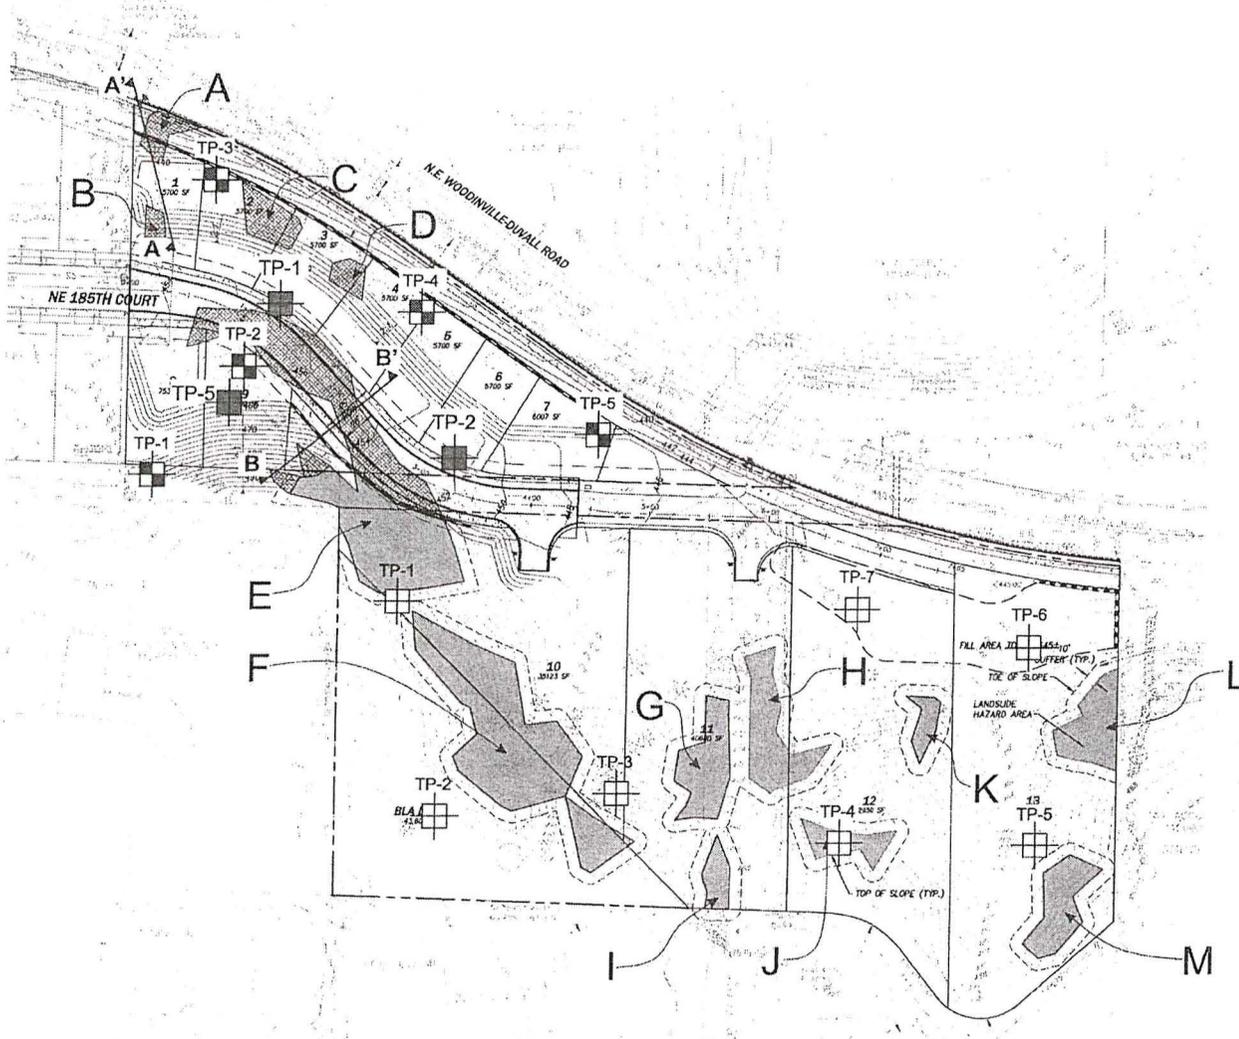
Figure 1  
 Site Plan  
 Brickyard Ridge, LLC: Brickyard Ridge

The steep slope areas to be altered are shown on Figure 1. We included two cross-sections to represent the conditions in steep slope areas A, B, C, D and E.

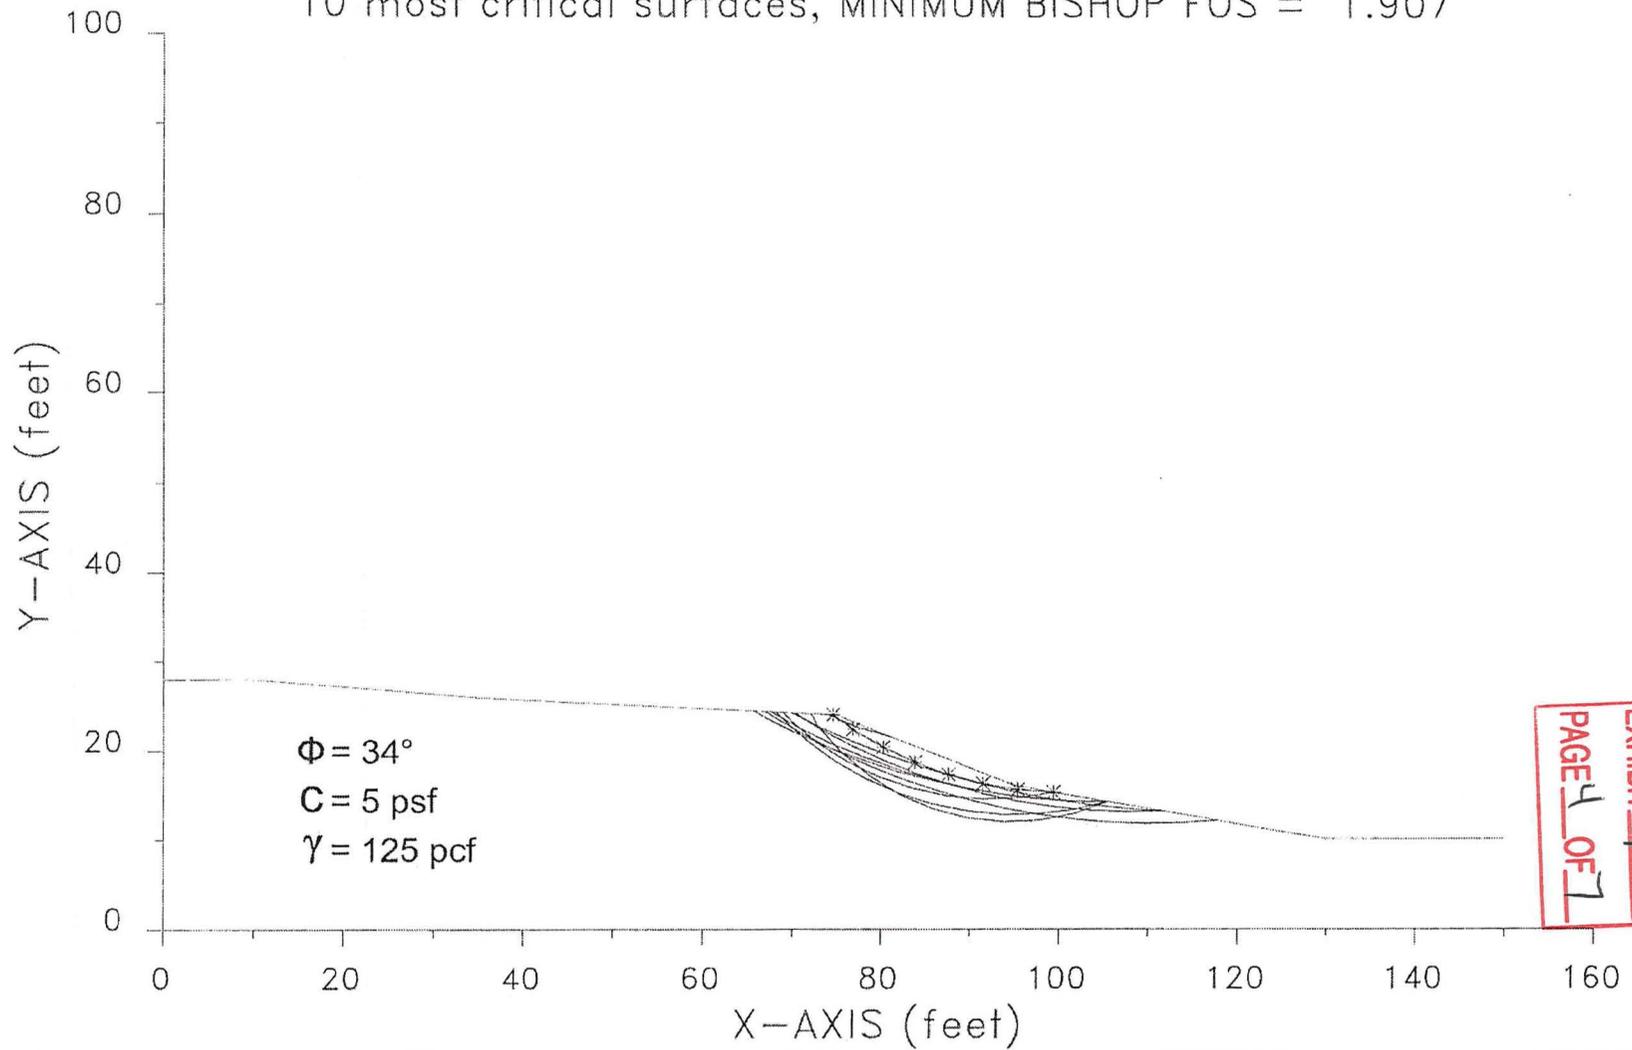
The site is underlain by glacially consolidated soils. The test pit logs are included in our geotechnical report. Based on the geologic environment of the materials encountered, relatively high strengths could be used, although our model used more conservative values. Proposed conditions were used to model Cross-Section A-A' and existing conditions were used to model Cross-Section B-B'. The parameters and results are shown in Figures 2 and 4. Factors of safety against deep-seated failures under static conditions were above 1.5 for Cross-Sections A-A' and B-B'.

Brickyard Ridge—Cross Section A—A'  
10 most critical surfaces, MINIMUM BISHOP FOS = 1.907

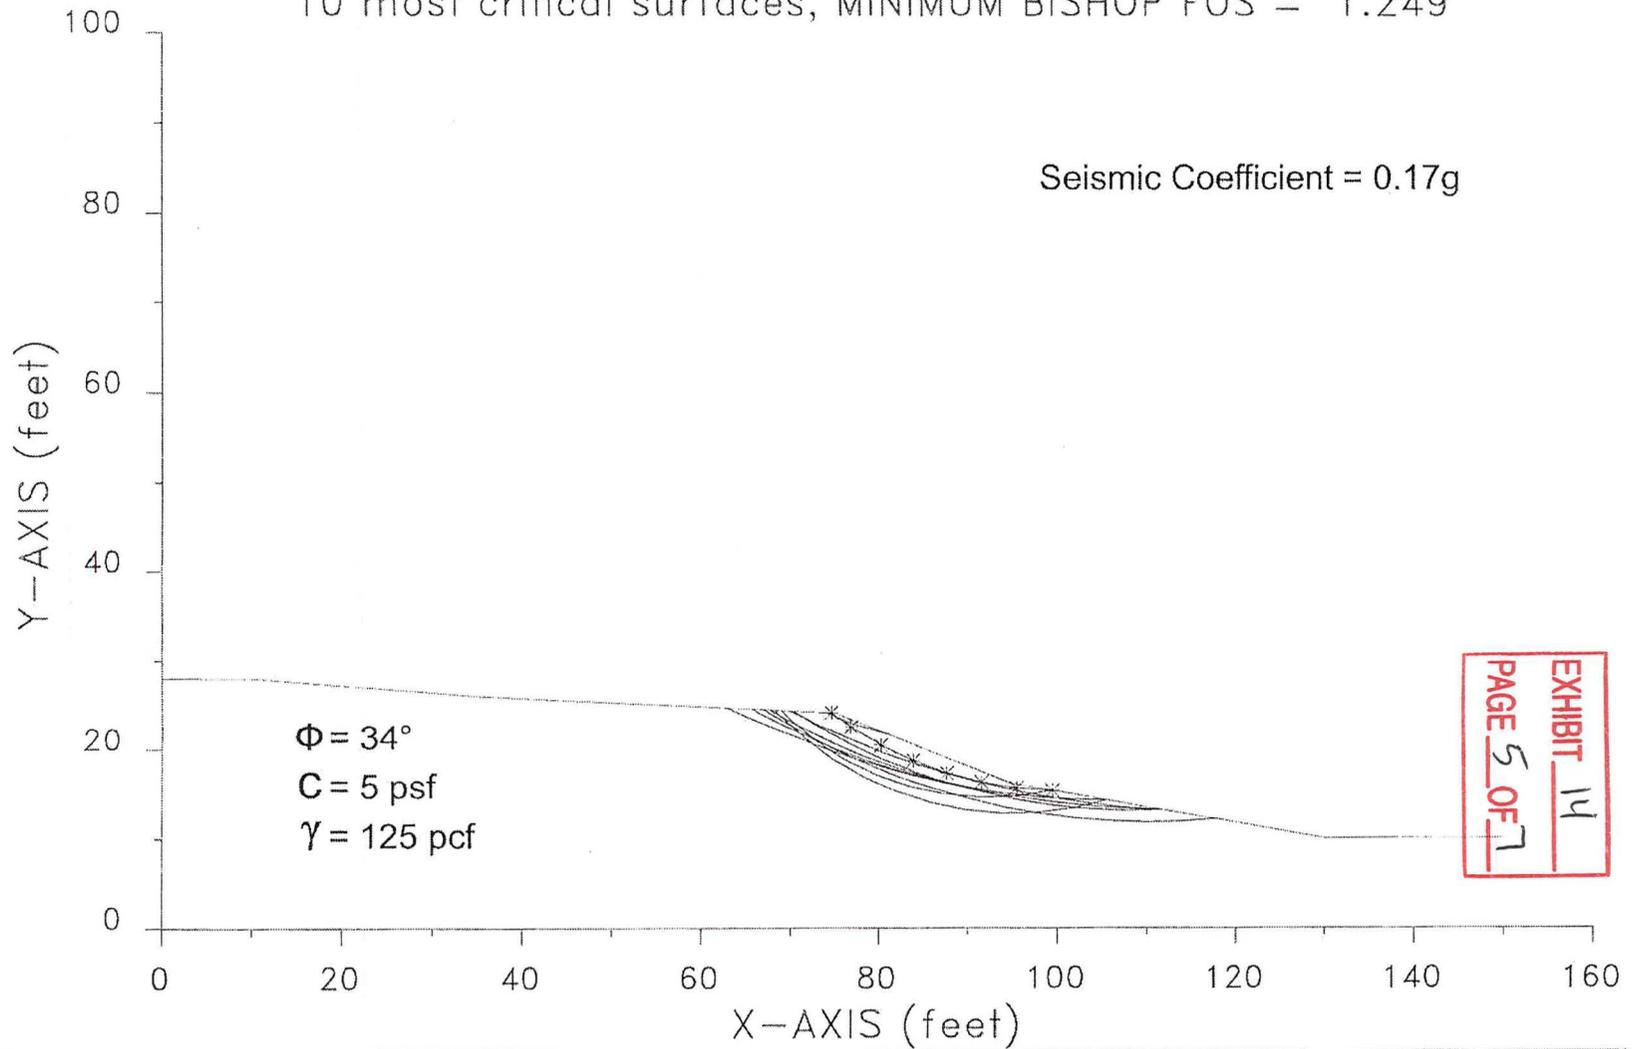
Figure 3

We used the static soil parameters in our seismic evaluation. We expect that for short intervals of dynamic forces, such as those created in a seismic event, the cohesion within the subsurface soils will be greater than the long-term internal resisting forces. We have used a small portion of the cohesion in the dynamic analysis. Therefore we consider the dynamic results to be conservative. The parameters and results are shown in Figures 3 and 5. Factors of safety against deep-seated failures under seismic loading were above 1.2 for Cross-Sections A-A' and B-B'.

### Brickyard Ridge—Seismic x—Sec A—A'

10 most critical surfaces, MINIMUM BISHOP FOS = 1.249

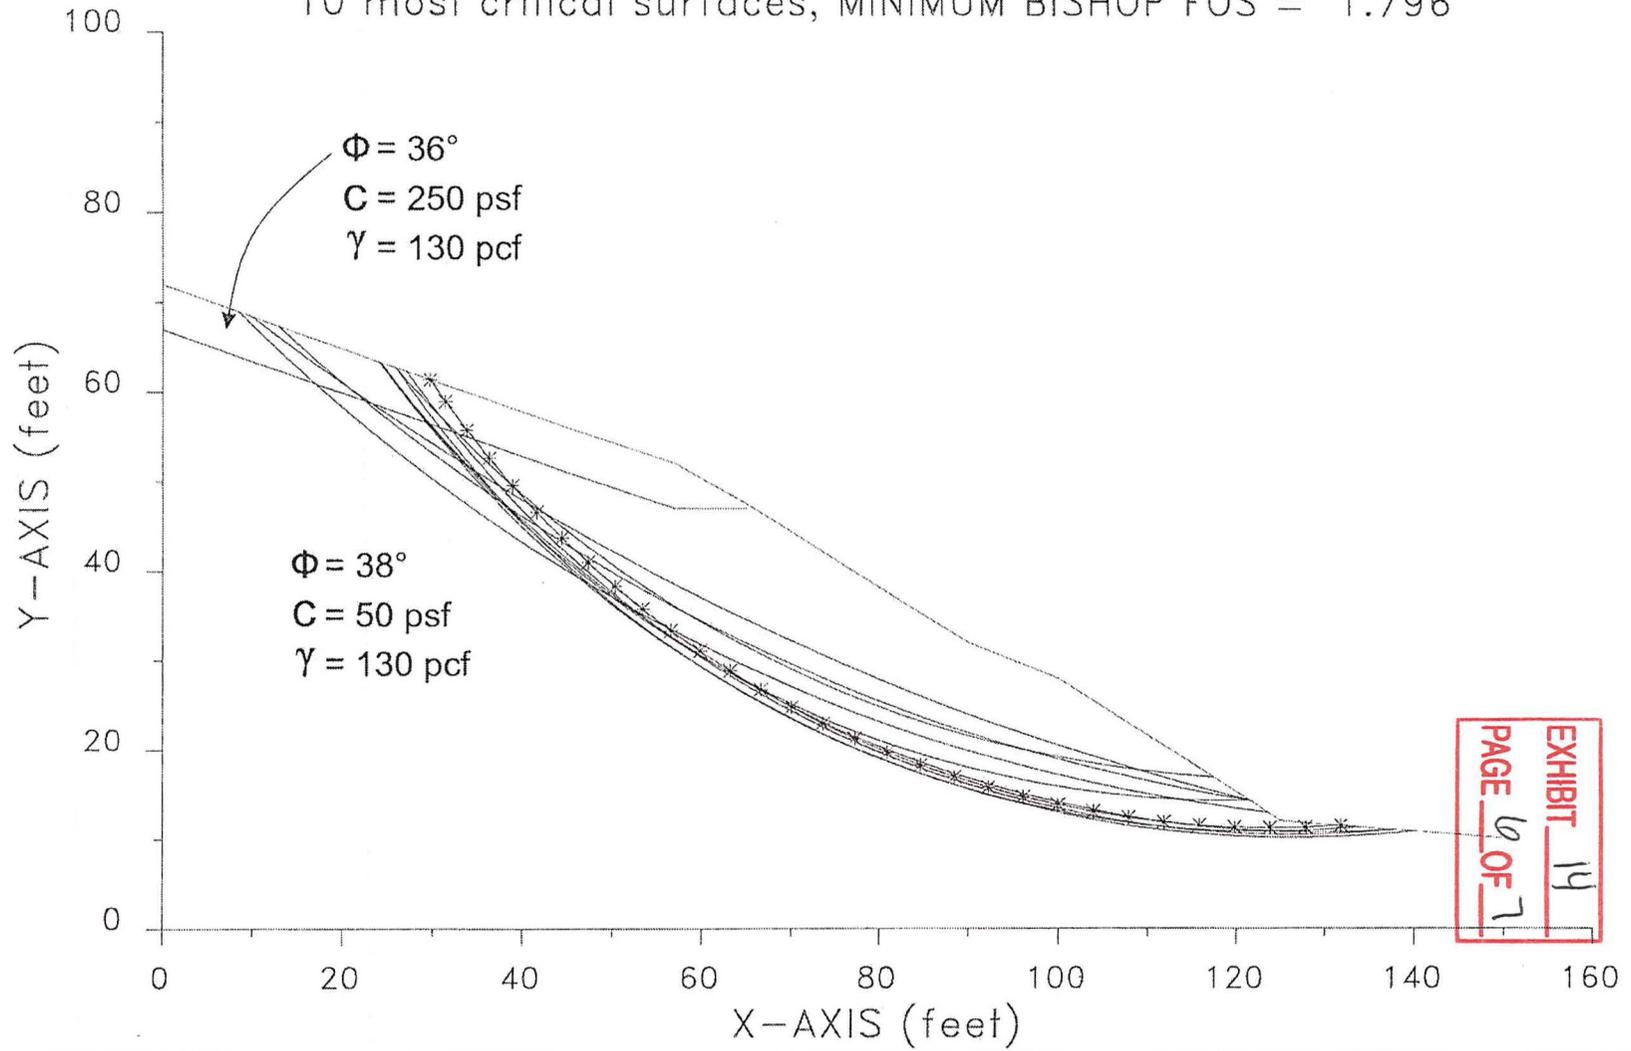
Brickyard Ridge—Cross Section B-B'  
10 most critical surfaces, MINIMUM BISHOP FOS = 1.796

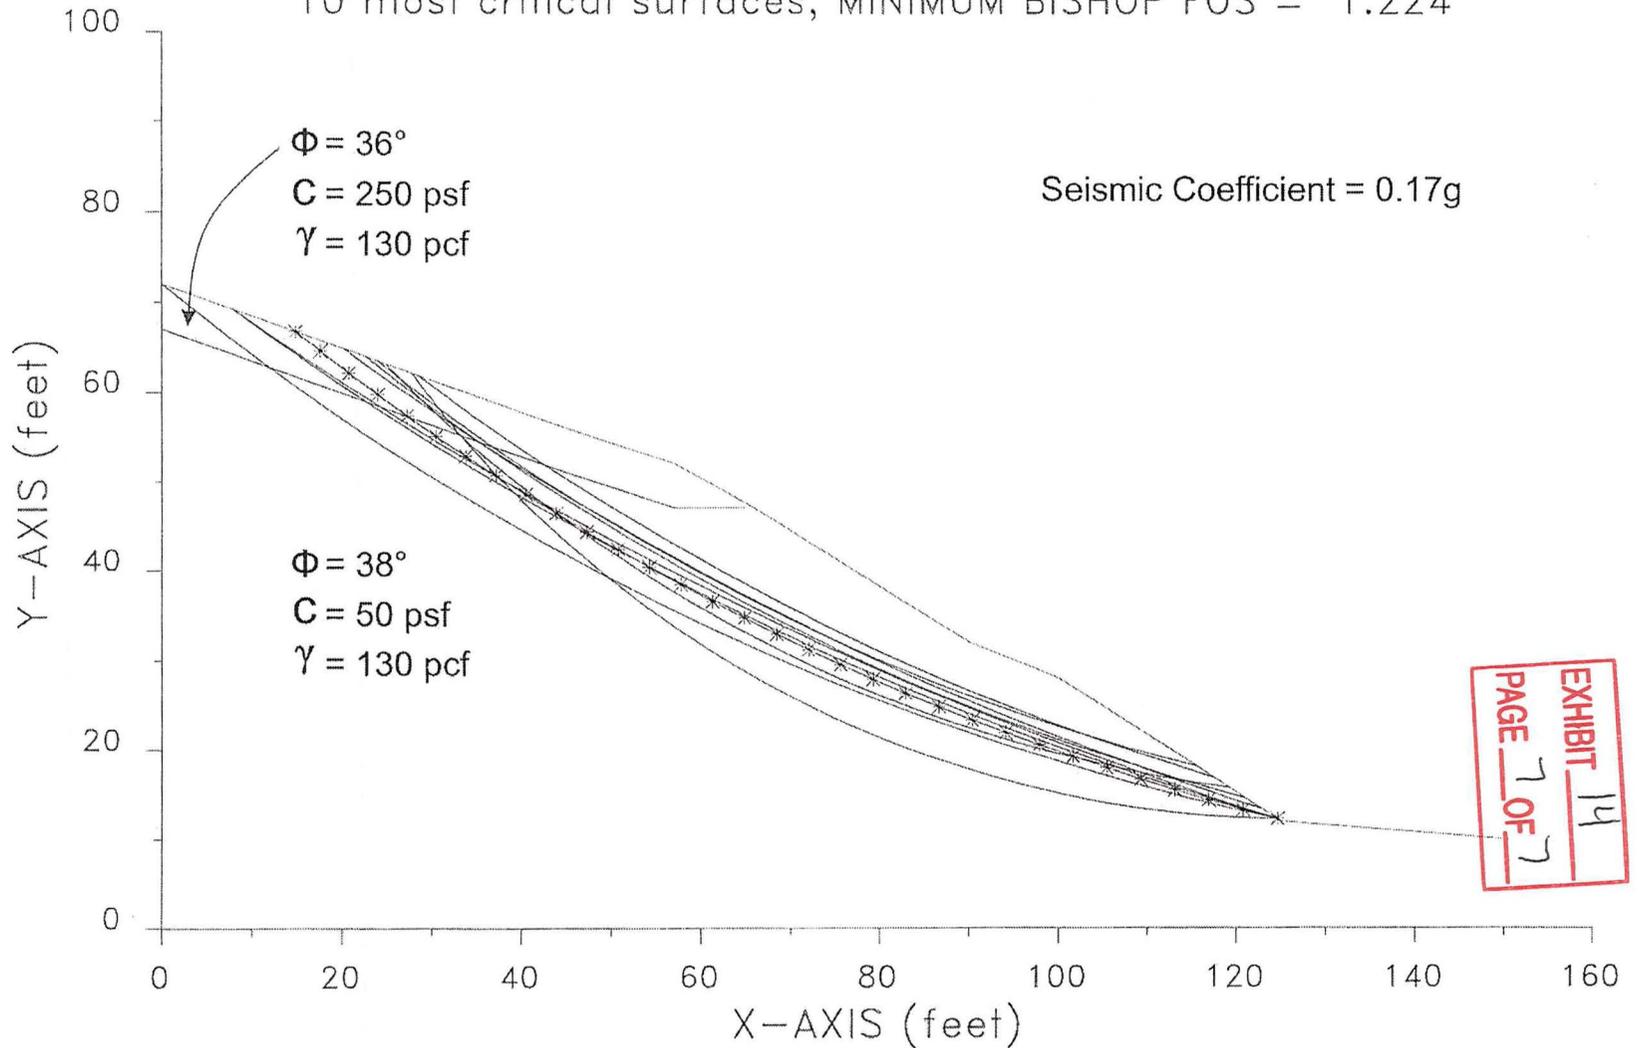
Brickyard Ridge—Seismic x—Sec B—B'  
10 most critical surfaces, MINIMUM BISHOP FOS = 1.224
