## EVALUATION OF SIX INCH AND LARGER TREES

## THE RESERVE AT WOODINVILLE

15902 Woodinville-Redmond Road  
Woodinville, WA 98072

**Revised June 6, 2016**

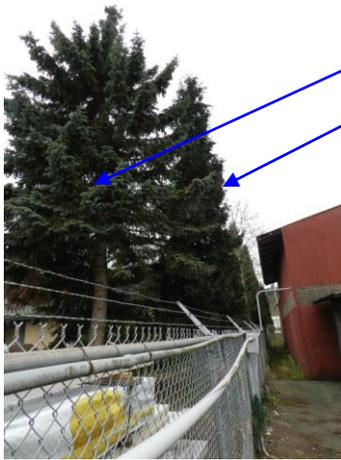
Photo # 1: looking NW from the northern end of the south property line at trees # 401 and 402 on the adjacent property to the south

Trees 401 – 407 can all be adequately protected during re-development with the standard 5-foot minimum setback

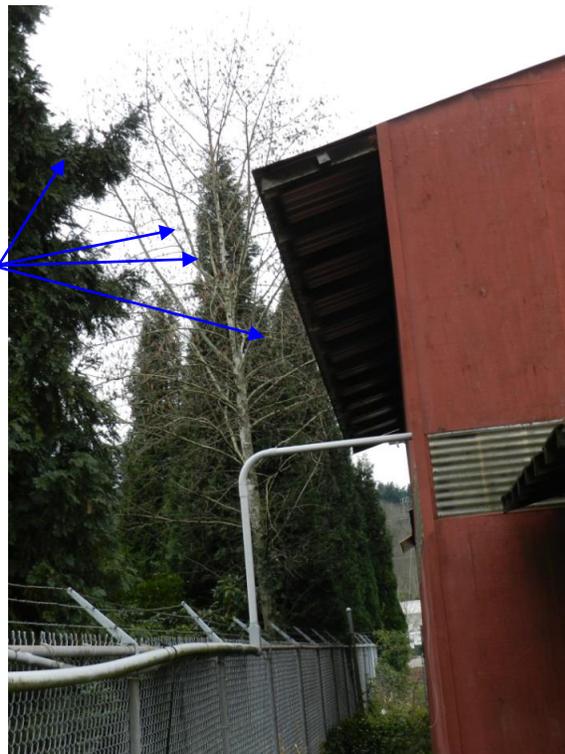
Photo # 2: looking at trees # 403 – 407 on the adjacent property to the south.

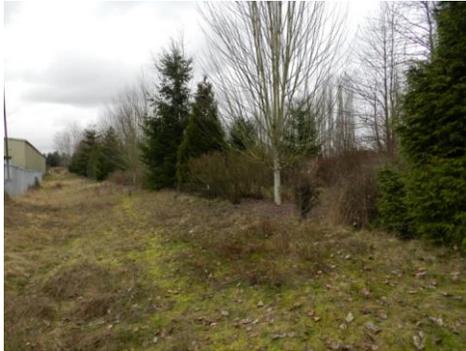
Photo # 3: looking north from near the southeast property corner at the western row of installed trees and grass.

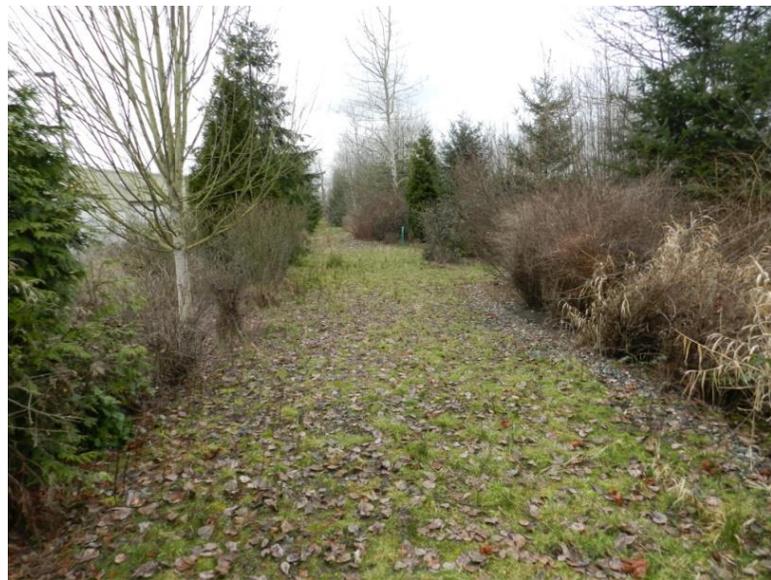
Photo # 4: looking north from near the southeast property corner between the two rows of installed trees and grass.
