STATE OF WASHINGTON
DEPARTMENT OF ECOLOGY

RE: Verification of Wetland Rating and Boundaries for the Modi Property, Project Number: SEP14023 / CAE14001

Wetland Rating

Wetland Delineation

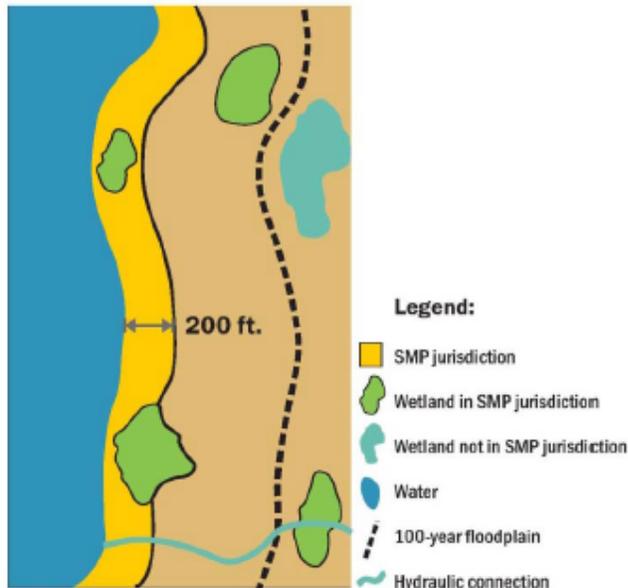
Figure 5-16: Wetlands in shoreline jurisdiction are either fully or partially within 200 feet of the OHWM, within the floodplain, or associated through hydraulic continuity.

Figure 1. Figure 5-16 from the SMP Handbook showing the relationship between SMP jurisdiction and associated wetlands.

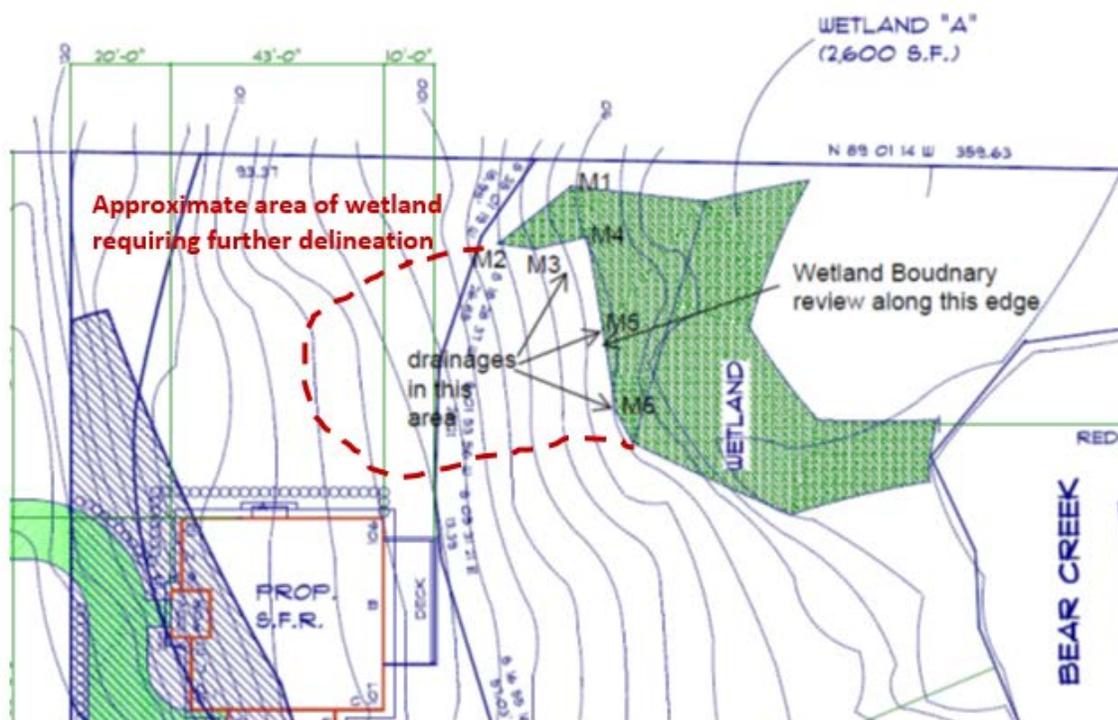
However, as we discussed onsite during our recent site visit, I cannot concur with the overall boundary of Wetland A because I saw indicators of wetland plants, soils and hydrology within an area of emergent vegetation (giant horsetail; *Equisetum telmateia*) upslope and well outside the flagged boundary of Wetland A (Photograph 1, below). The wetland indicator status of giant horsetail is Facultative Wetland: plants that usually occur in wetlands, but are occasionally found in non-wetlands (Tiner 2012). Soils throughout this area were saturated to the surface, to the point where it was a challenge to walk without sinking into the mud. I dug a soil pit in this area and the surface layer of soils were a muck or mucky mineral soil (Photograph 2, below) that reacted positively to dipyrindyl paper, showing that the soils were in a reduced condition; due to prolonged saturation, reduced iron (Fe^{++}) was present). This area was dominated by emergent vegetation and there were no trees growing within it, likely because this area is too wet.

The horsetail meadow appeared to be a few hundred square feet in area, extending downhill to or very near the flagged wetland boundary and I believe is likely an extension of Wetland A. If not an extension of Wetland A, it is a separate wetland that will need to be delineated, rated and shown on the site plans. A portion of the area in question is labelled with "drainages in this area" on the site plan from the Cooke Scientific report. An excerpt of that site plan is shown below and I have added an approximate outline (red dashed line) of the additional wetland area requiring further investigation to the site plan.

Figure 2. Excerpt of site plan from Cooke Scientific report with added outline (red dashed line) showing the area requiring additional wetland investigation based on observed wetland indicators seen during May 5, 2016 site visit.

Once this additional area has been delineated and rated, I would be happy to field-verify those findings. As of January 2015, Ecology has required that any field work for wetland ratings use the 2014 update to the state rating system. Also, any earthwork within wetlands will require state and federal approvals in addition to any City authorizations or exemptions.

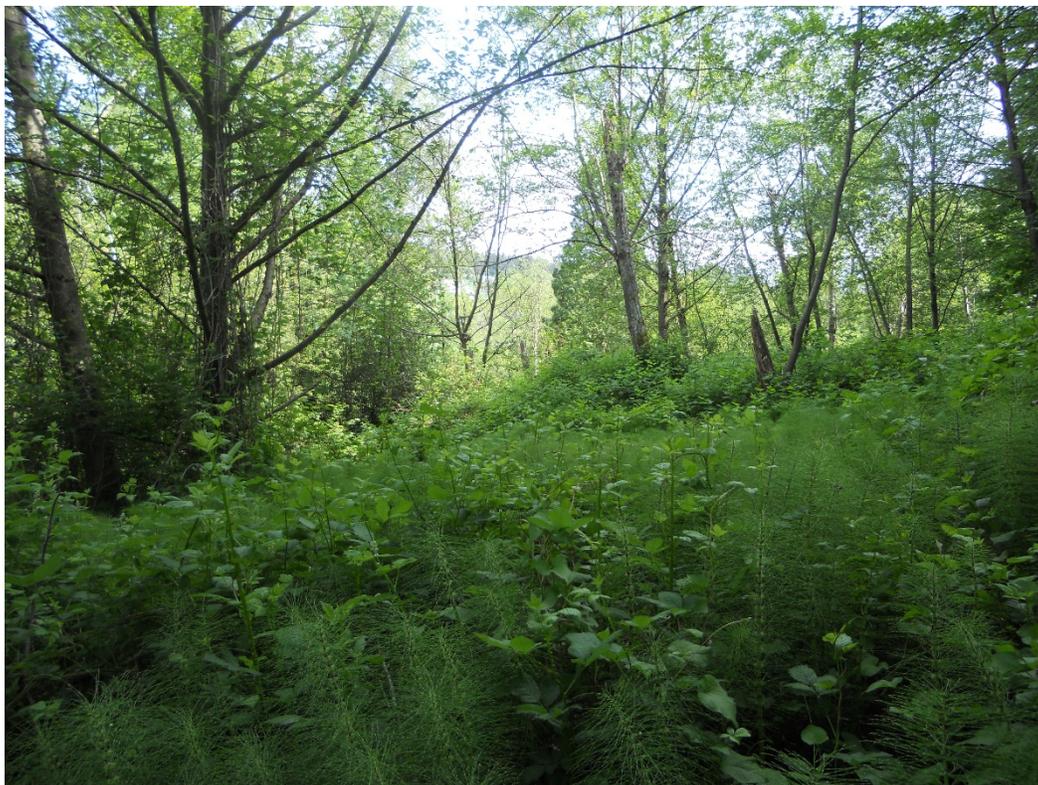
Photograph 1. Upslope end of emergent vegetation and wet area outside of delineated wetland boundary as seen during May 5, 2016 site visit; facing southwest.

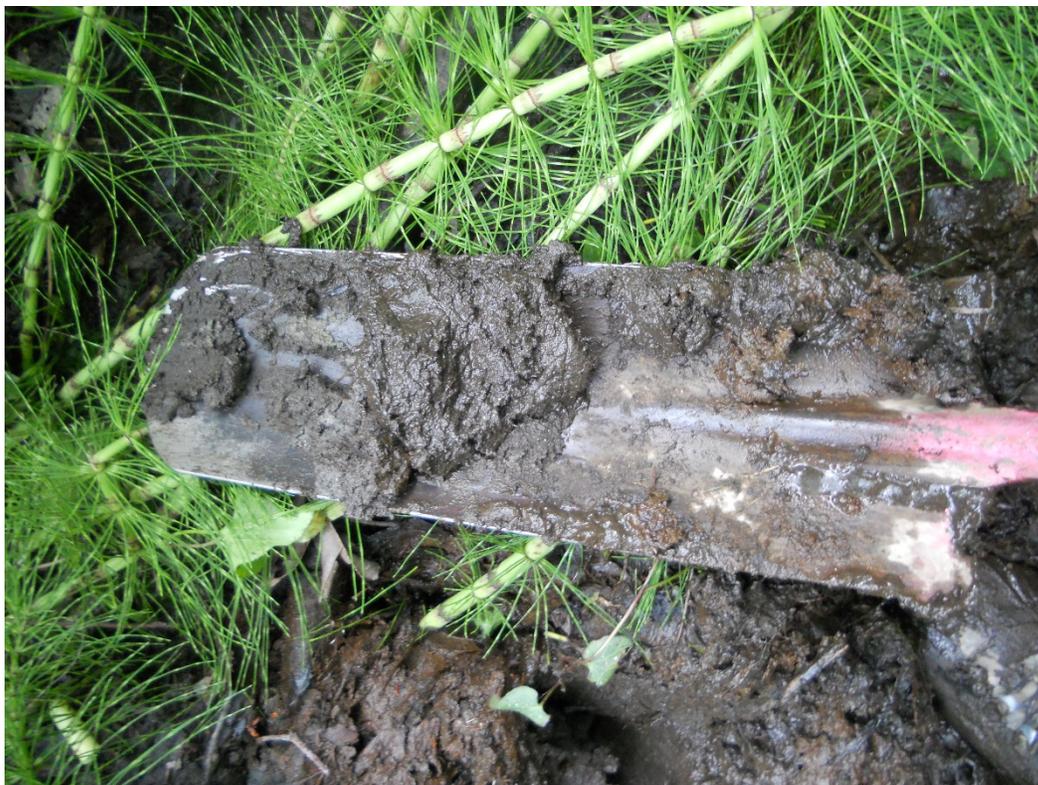
Photograph 2. Saturated muck/mucky mineral soils seen outside of delineated wetland boundary during May 5, 2016 site visit. These soils reacted positively to dipyriddy paper showing that they were in a reduced condition.
