### Memorandum

TO: Prakash Modi  
FROM: Sarah Spear Cooke  
DATE: February 24, 2016  
SUBJECT: Wetland A Western Edge Boundary Verification, City of Woodinville, Wa.  
Woodinville Project #32204L

# Modi Property, Woodinville

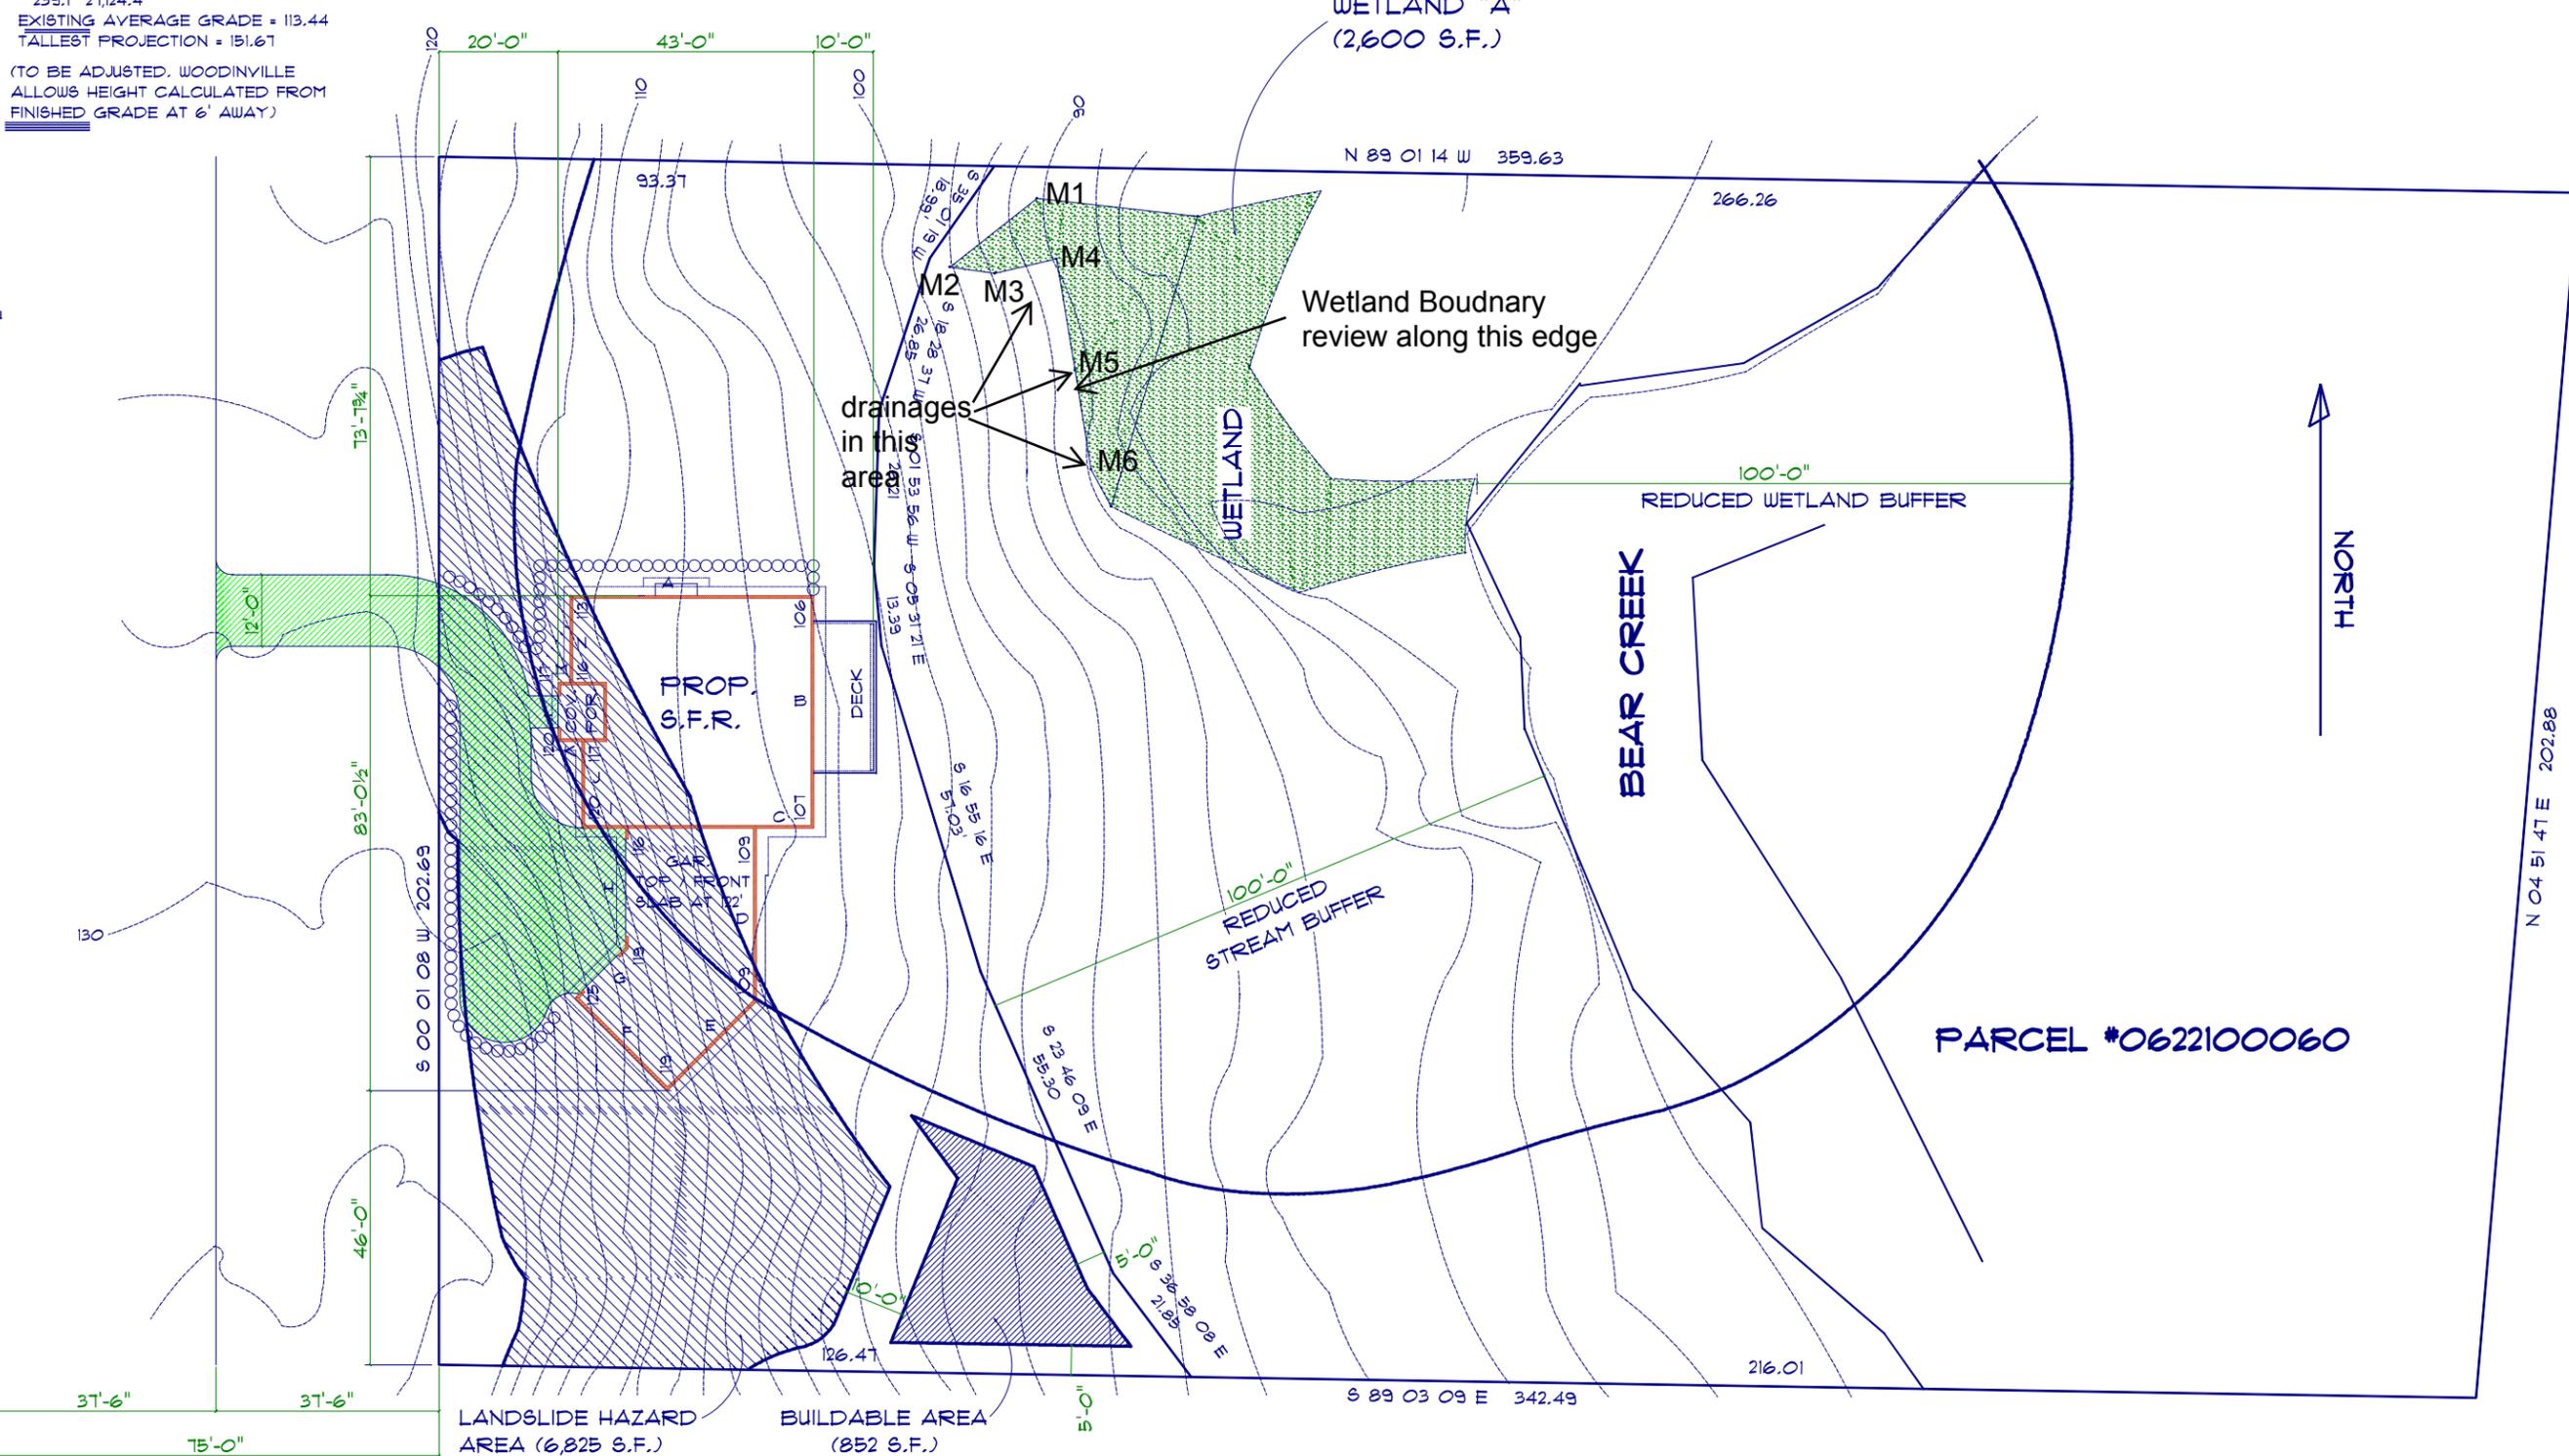
**SITE PLAN**  
SCALE: 1" = 30'-0"

Based on my professional experience a re-evaluation of western boundary was done between the edges identified by the City of Woodinville in January 2016. New wetland flags, shown on Figure 1 correctly reflect the new wetland boundaries at the time of the site visit in January 2016. This boundary was established with the vegetation criteria missing because of the time of year (winter) and the soils were saturated and all looked hydric, possibly due to prolonged winter rains.

I placed 6 flags along the western edge of Wetland A (Figure 1); starting from the northwestern flag of wetland A that connects to Flag M1 and ending at Flag M6 that ties to the wetland flag at the southwest corner of Wetland A. The vegetation found around flag M1 (Photo P2) was 30% pacific ninebark (*Physocarpus capitatus*, FACW), 15% salmonberry (*Rubus spectabilis*, FAC), 60% Sitka spruce (*Picea sitchensis*, FAC), 35% red alder (*Alnus rubra*, FAC), and 10% pig-a-back (*Tolmea menziesii*, FACW) . The soils were very dark (2.5YR4/2) organic-rich sandy loam. There was water to the surface of the soil for most of this area and certainly within the top 6-inches of the soil surface when the soil was augered.

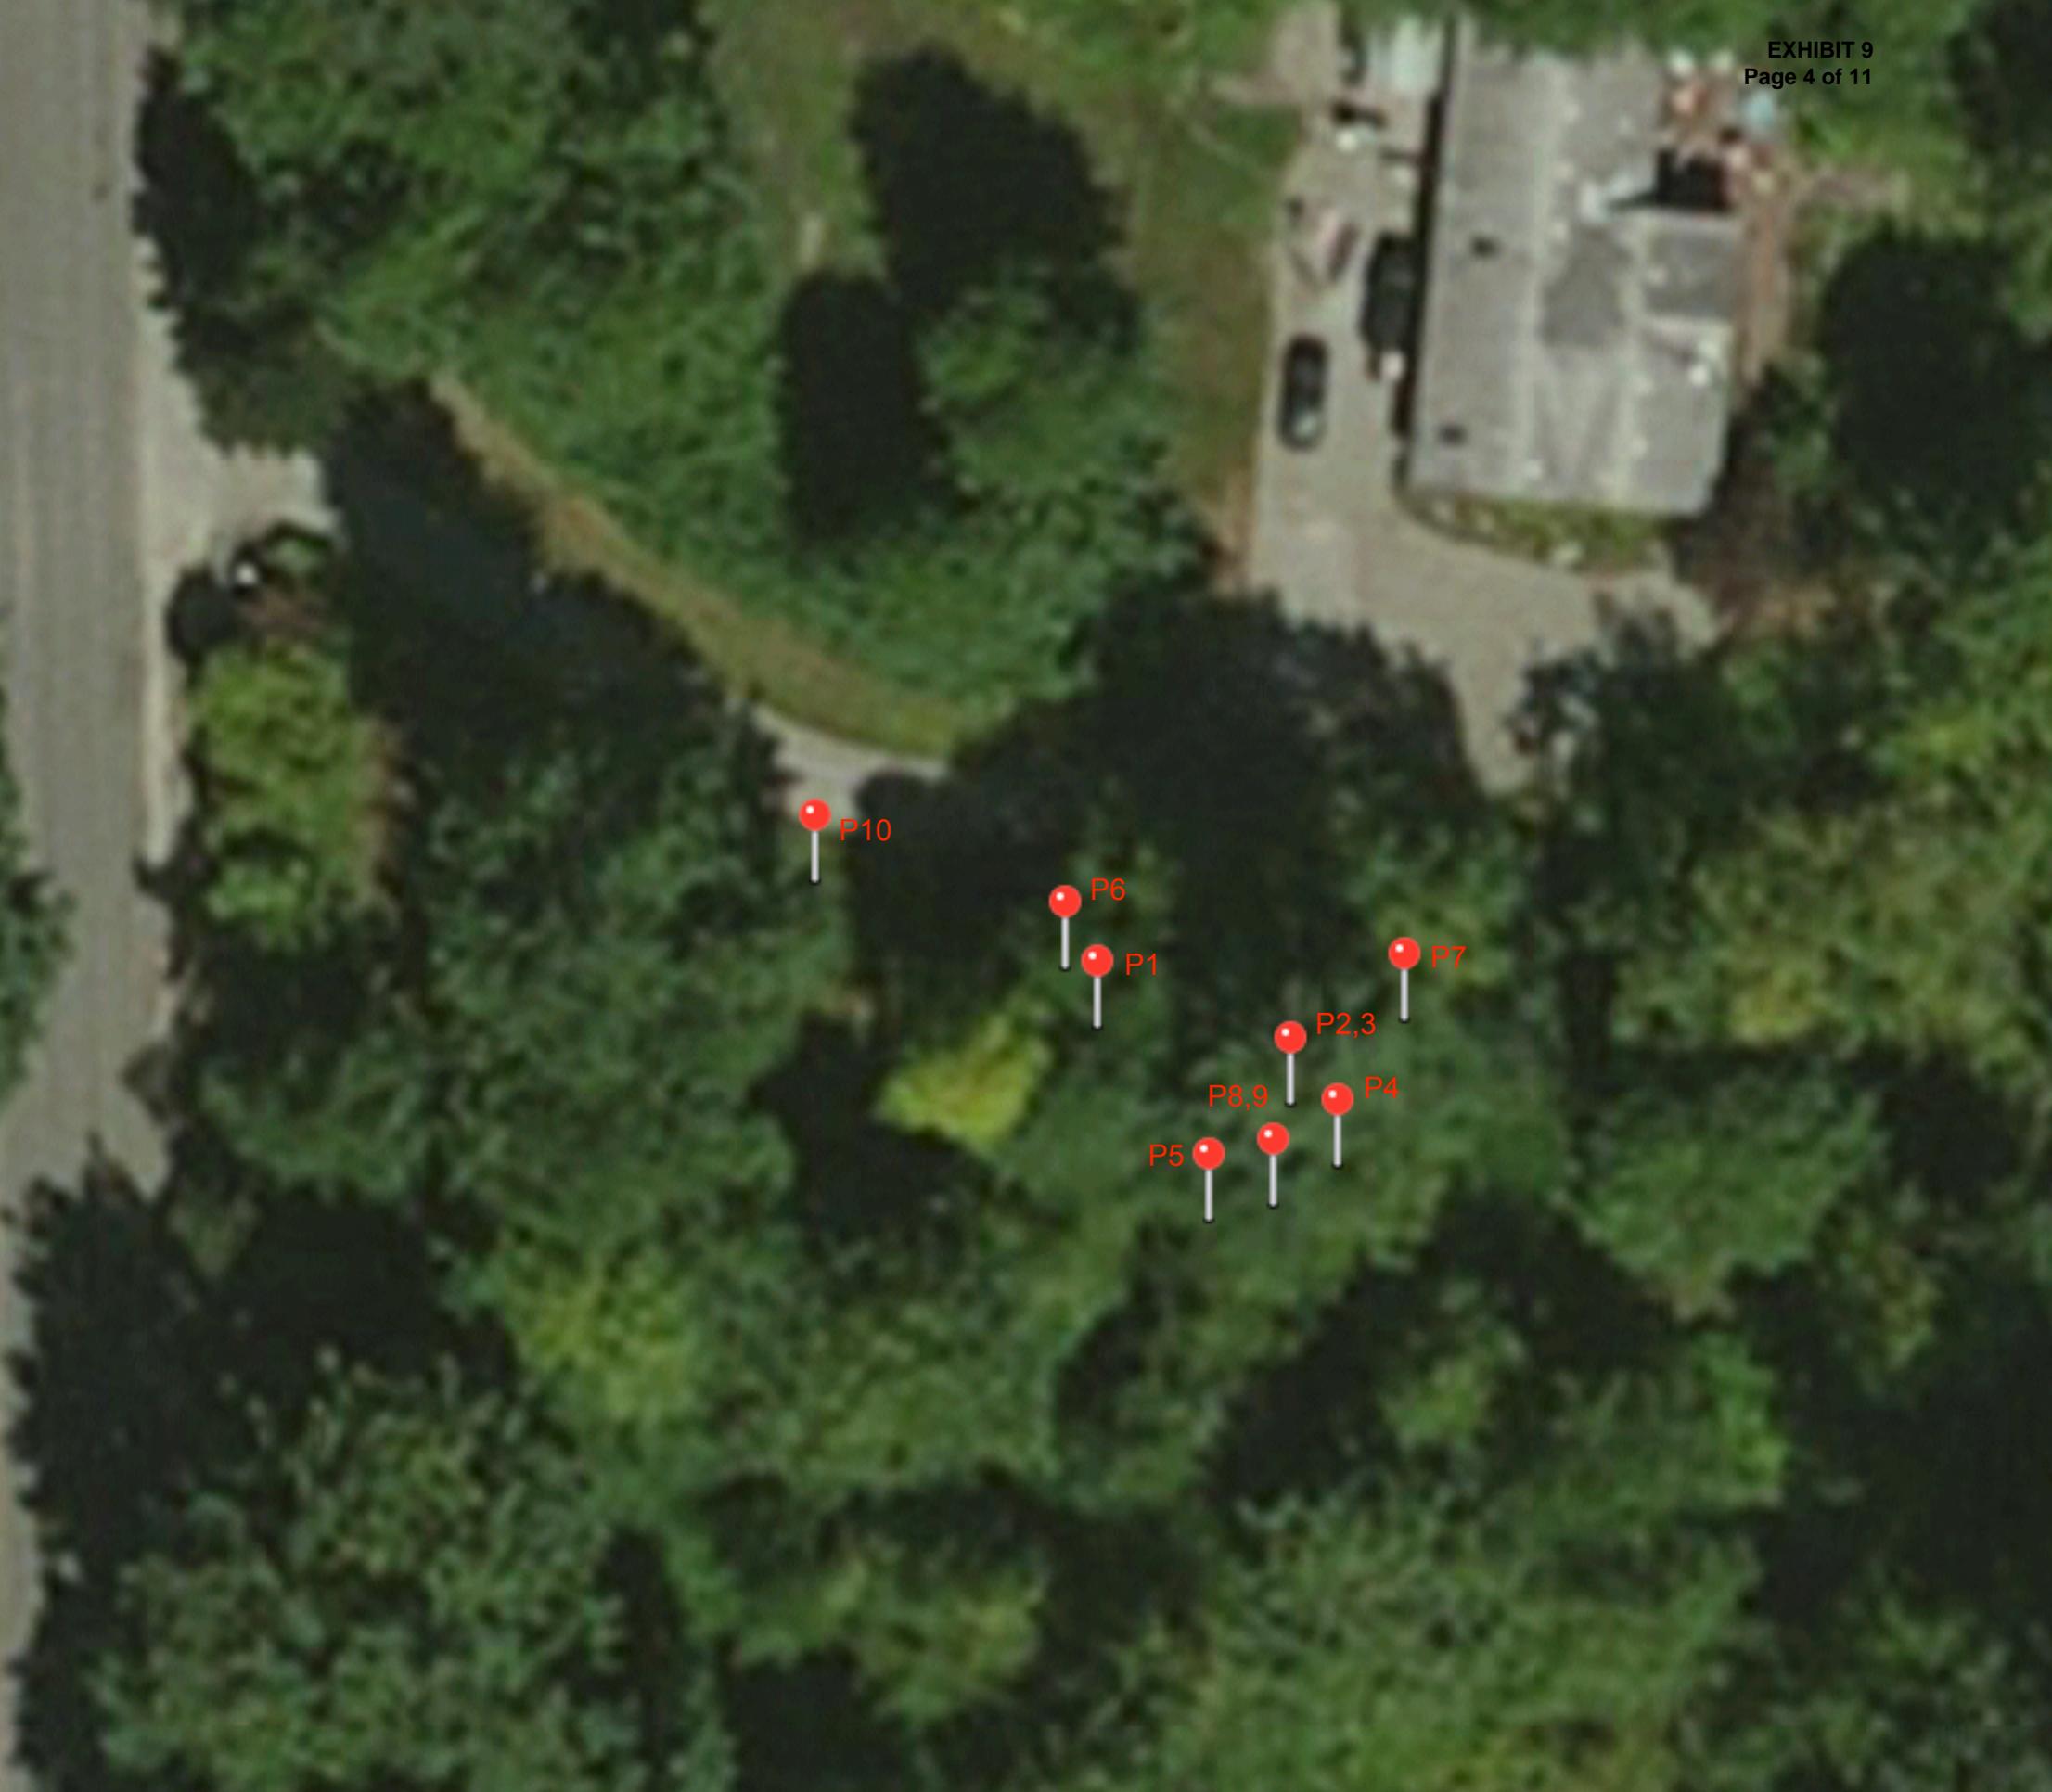
**Summary of Site Visit Findings:** (Photos P1-P10, including photo location map)

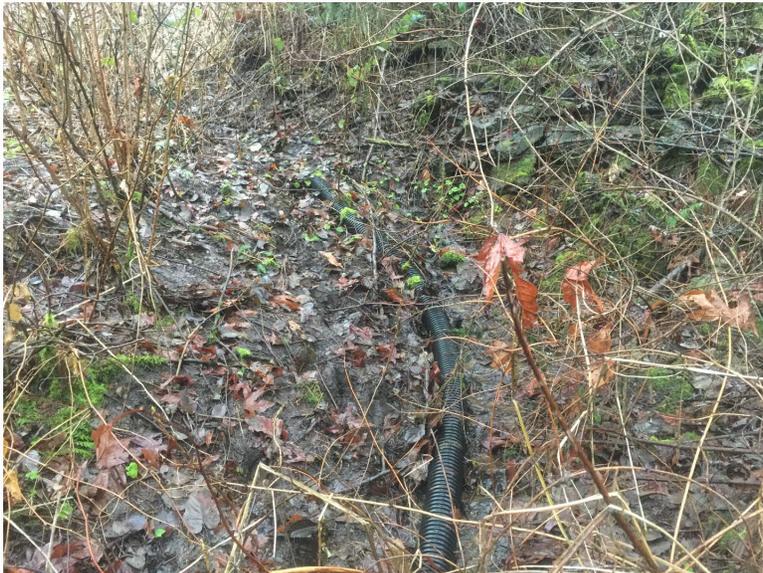
P3.JPG

Flags M1, M2, M3, and M4 define a channel heading upslope to just below the flat area that contained 1-2-inch deep water at the time of the site visit. There is a plastic pipe lining this channel that is conveying water from an unknown uphill source (Photos P3, P4, P5). There is a concrete rubble pile just north of this swale that restricts the flow in this channel southward (photo P1). The channel was eroded into the highly organic black soil (10YR3/1) (P5) that is present on much of the slope that I could access. There was a significant amount of blackberry and downed woody debris making access difficult throughout much of the slope. There was no vegetation present in this channel, only overhanging trees that were not rooted in the wetland. There were no emergent species present at this time of year and all the species present were FAC (Sitka spruce, red alder and salmonberry) with the exception of the sword fern (*Polystichum munitum*) so the ferns growing on slightly higher elevation hummocks were used to determine the wetland boundary to the south between flags M3 and M4.

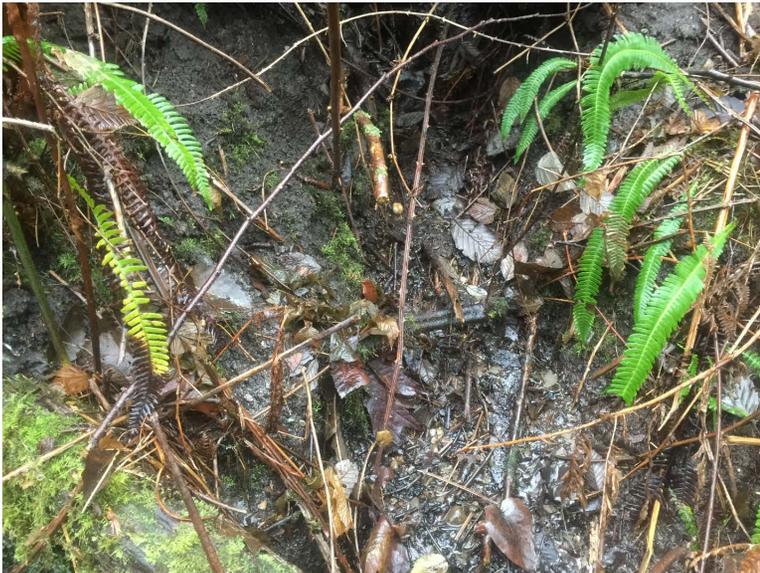
P7.JPG

I found drainages that initiate somewhere between the upper level area (where the development pad is located), and the wetland edge in at least four locations. Three of the drainages were seen right as the slope transitions from grading gently downhill and drops abruptly to the lower previously delineated Wetland A edge along the line formed by the new boundary flags M4, M5, and M6 (Photos P7 and P8). Unfortunately there was a very large downed tree, many smaller downed trees and a thick patch of blackberry (*Rubus armeniacus* (FACU) and other FAC species such as salmonberry and red alder, in this area so no further investigation was possible further uphill to the west to see if the drainages continued up the slope from the edge marked by Flags M4 – M6 (Photos P7, P8). The old Acera wetland edge is shown as photo P9 right near the southwest flag of Wetland A.
