# Memorandum

To: Aaron Silver and Grace Kane, DMJM Harris  
From: Bob Elliot and Sam Gould, Northwest Hydraulic Consultants  
Date: May 10, 2007  
Re: Hydraulics for Woodinville SR202 Bridge

This technical memorandum outlines the hydraulic analysis conducted by Northwest Hydraulic Consultants (nhc) for the Sammamish Bridge and Road (SR202) project. The work carried out by nhc included fieldwork to set current and high water marks, developing and calibrating an updated hydraulic model of the study area, and calculating the water surface elevation at the highway bridge. Each of these items is discussed below.

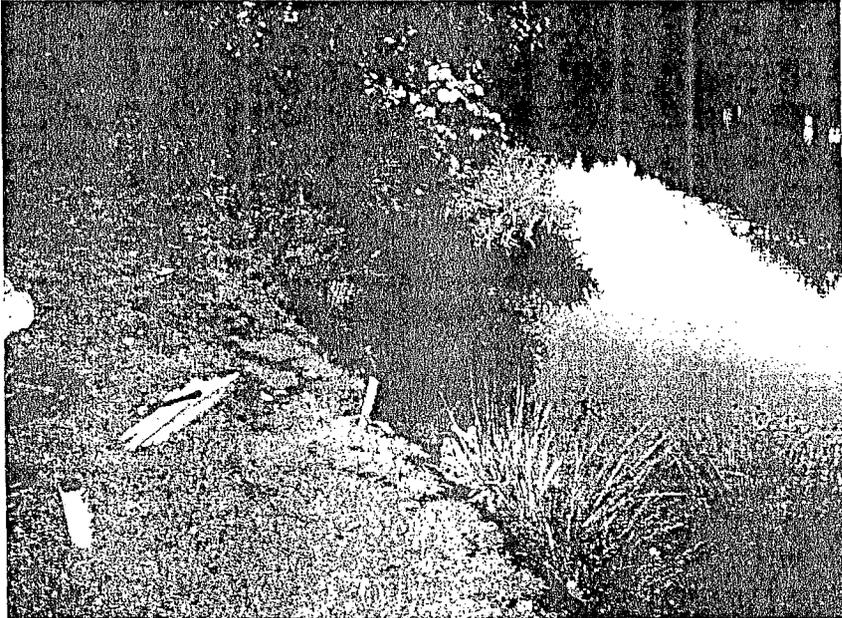
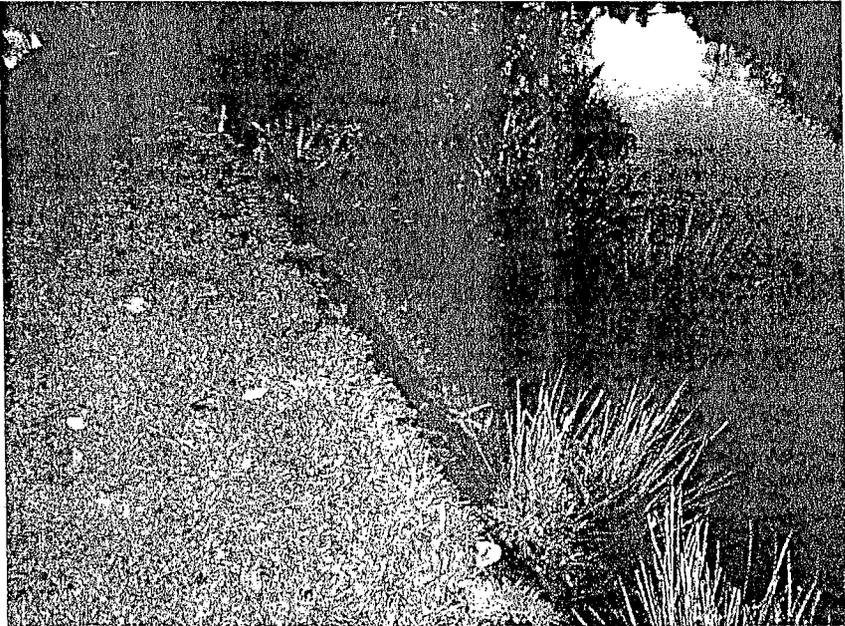
Mark A is located on the right bank upstream of the most upstream railroad bridge. The mark is located where the grass amphitheater meets the river bank. A stake is driven in ground at the current water level. In addition to the stake, orange paint was used to mark the current water level on a log located at the river bank.

Photo 1. Current water level mark A

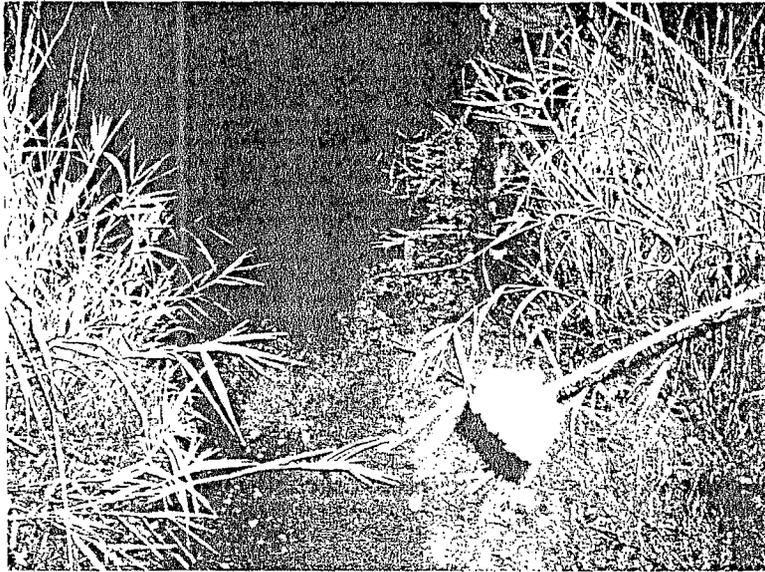
Mark D is located on the right bank downstream of the most downstream railroad bridge. The mark is a stake driven in the ground at current water level. The stake is directly down the river bank slope from the North Creek Force Main Drain Structure #2 Sump Control Panel.

Photo 4. Current water level mark D

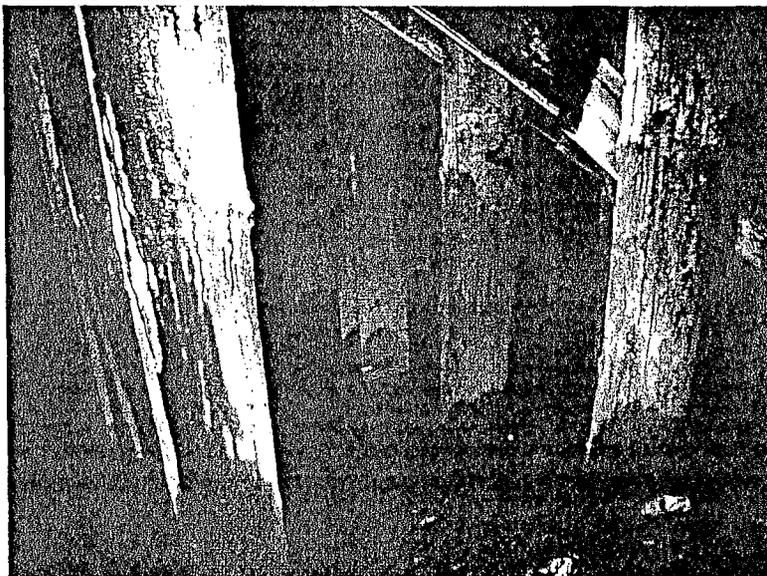
Mark E is located on the left bank on the middle pilings of the most upstream railroad bridge. The mark is a horizontal orange paint stripe on 2 steel pilings. The bottom of the stripe denotes the current water level.

Photo 5. Current water level mark E

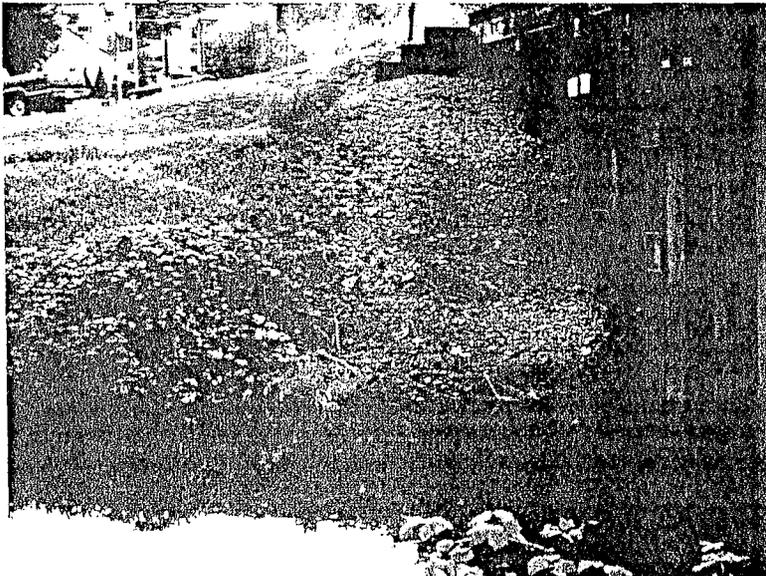
Mark 2 is located on the left bank of the upstream railroad bridge. The stake is in the ground approximately 10' upstream of pilings. The mark is the upper limit of settled grasses and small reeds.

Photo 7. High water mark 2

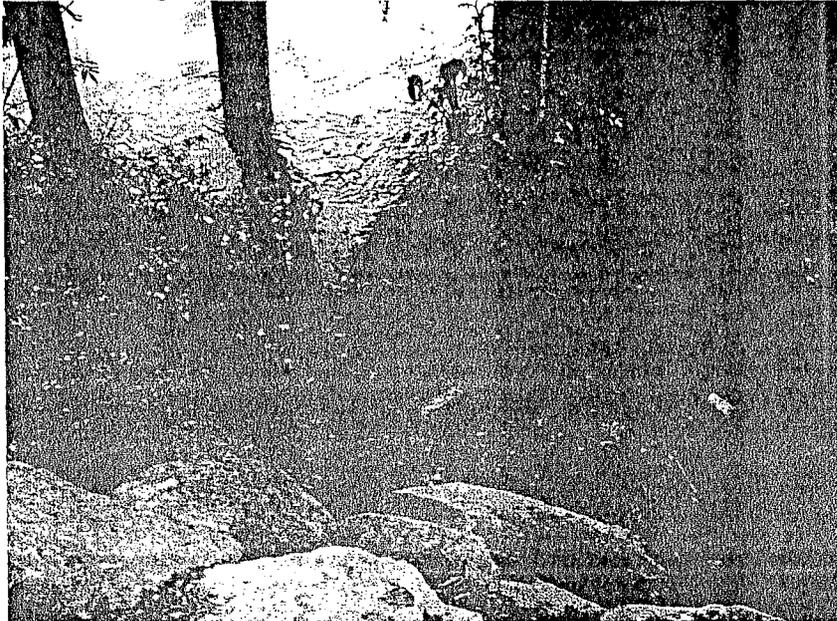
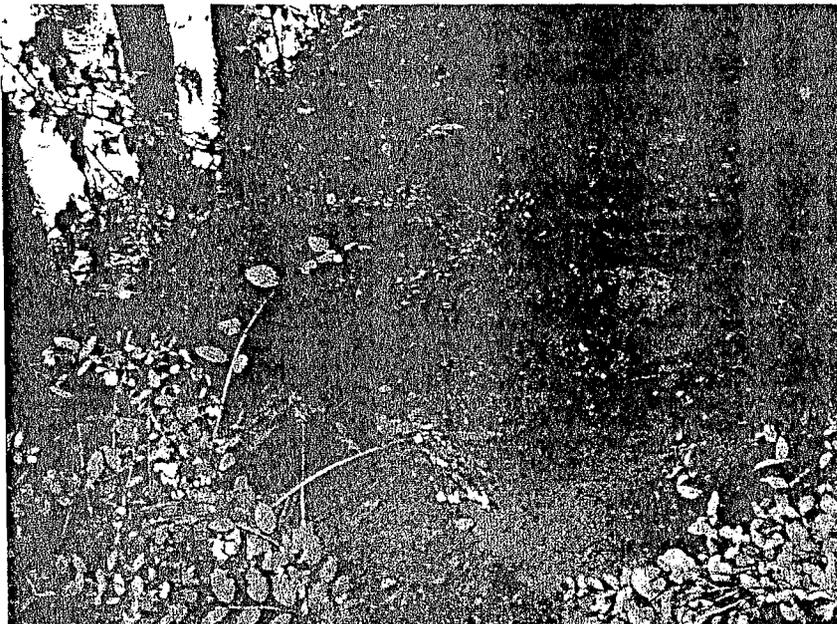
Mark 3 is located on the right bank of 175<sup>th</sup> Street Bridge (middle bridge). The stake is directly under the middle center line of the bridge/roadway. The stake is driven at the location of grass/leaves that were caught in an adjacent bush.

Photo 8. High water mark 3

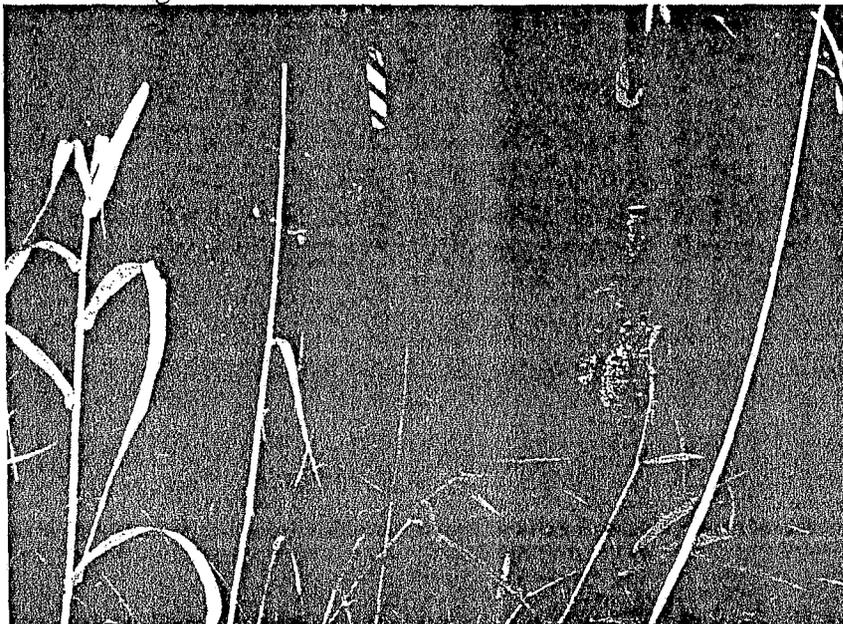
Mark 4 is located on the right bank downstream of the most downstream railroad bridge. An orange ribbon is located about 100' downstream of bridge pilings. The ribbon is tied on a branch of a tree on the bank adjacent to the river. The mark identifies debris that collected in branches.

Photo 9. High water mark 4
