# Technical Memorandum

**To:** Tom Hansen, P.E.  
**From:** Nick Allmendinger, L.G., Ph.D.  
**Copies:** Nico Vanderhorst, Kevin O'Brien  
**Date:** July 13, 2011  
**Subject:** Mitigation Concepts for Woodinville-Duvall Road at Woodin Creek Park  
**Project No.:** 31423

**WOODIN CREEK  
MITIGATION CONCEPTS**

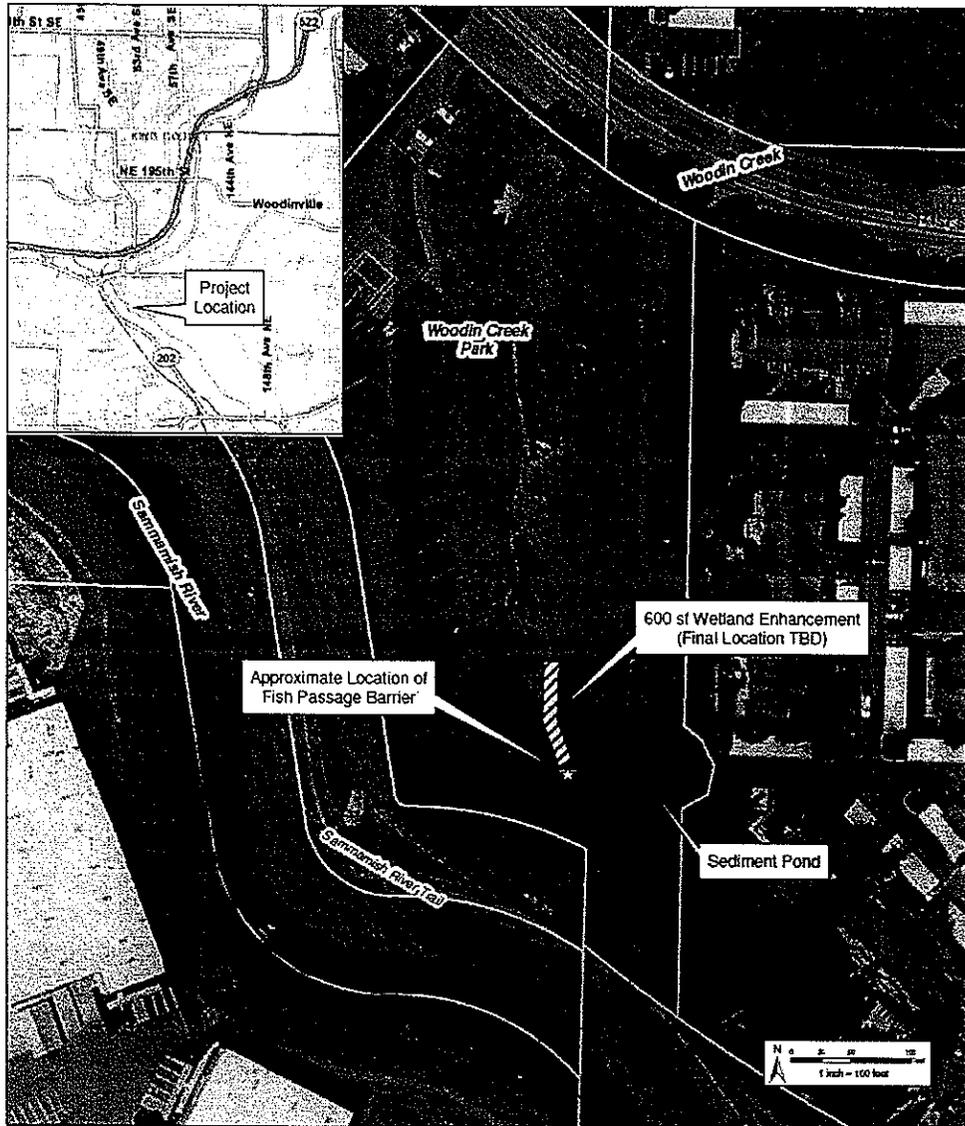
Figure 1. Mitigation concepts vicinity map

bittersweet nightshade, and reed canary grass), and installing appropriate native tree and shrub species (Figure 1). Due to the existing canopy present at the proposed project site, plantings will include shade-tolerant native shrubs and trees such as vine maple, pacific ninebark, wild clustered rose, salmonberry, snowberry, red osier dogwood, Sitka spruce, and western red cedar. A minimum area of 600 square feet will be enhanced to compensate for the 400 square feet of wetland impact along the Woodinville-Duvall Road at a 1.5:1 ratio. Specific planting plans are currently being prepared for the project.

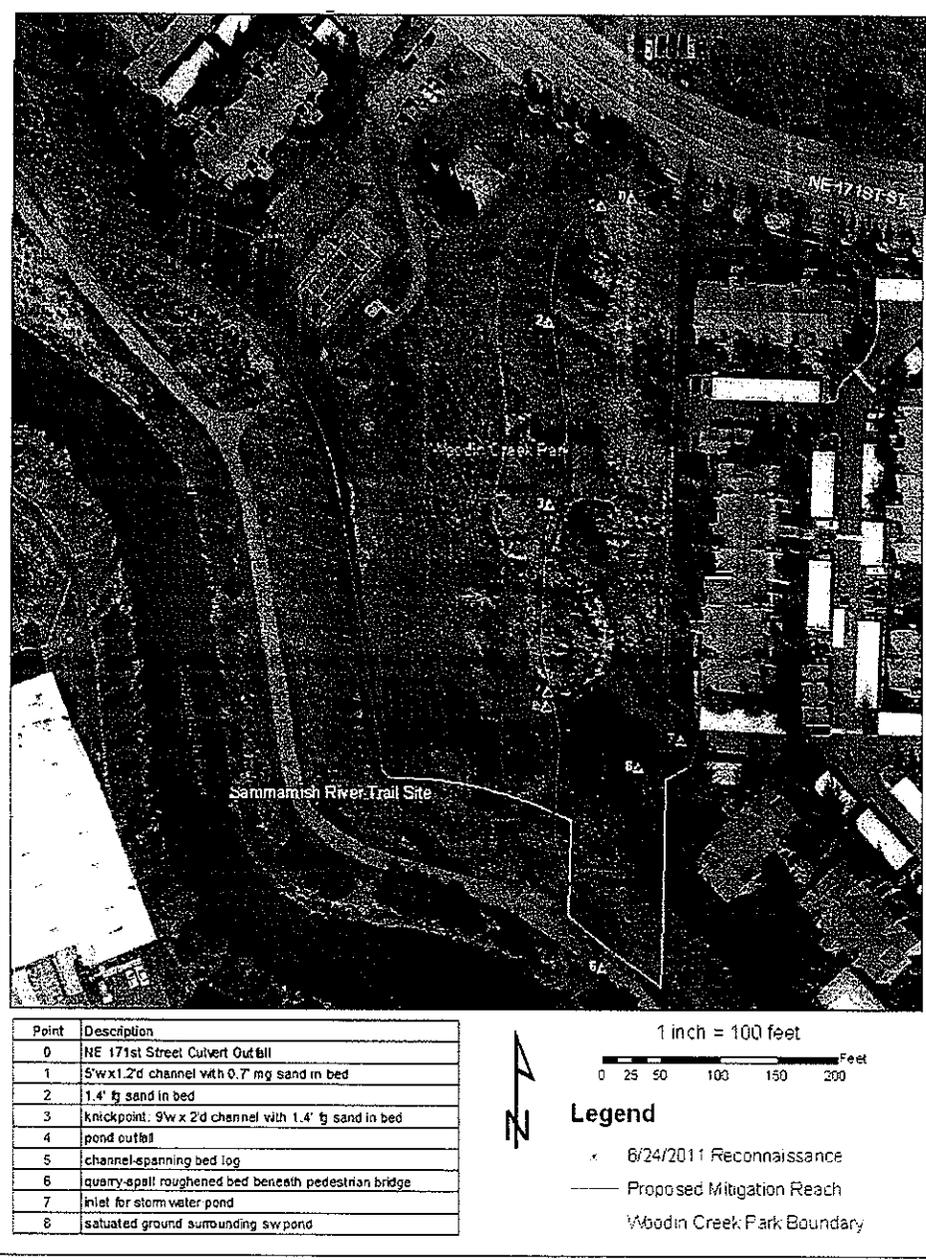
Figure 2. Reconnaissance Map from June 24, 2011 field visit.

Figure 2 in Appendix A and the photos in Appendix B illustrate points along the Woodin Creek system in Woodin Creek Park. Woodin Creek is conveyed beneath 131st Avenue NE (just north of where 131st Avenue NE becomes NE 171<sup>st</sup> Street) through a 48 inch corrugated metal pipe culvert (point 0 in Figure 2, photo 1 in Appendix B). Downstream from the culvert outfall, Woodin Creek has a fairly consistent bankfull width to depth ratio of 4.5 (4.2 to 5.0) with bankfull widths ranging from five feet near the upstream end (point 1, photo 2) to nine feet approximately 100 feet upstream from the stormwater pond outfall (point 3, photo 3). Bankfull depth increases in proportion to width from 1.2 feet near the 131st Avenue NE culvert to two feet upstream from the pond outfall. The channel capacity is reduced by significant aggradation of fine to medium-grained sand which has accumulated to a minimum thickness of 0.7 feet near the upstream end of the reach and reaches a maximum sustained thickness of 1.4 feet within 150 feet of the culvert outfall (point 2). This aggrading reach is lined with invasive vegetation species, dominated by reed canary grass. Near the downstream end of this reach, root-forced head cuts demonstrate a transition from a system dominated by aggradation to one dominated by incision (point 3, photo 4).

Point	Description
0	NE 171st Street Culvert Outfall
1	5 foot wide x 1.2 foot deep channel with 0.7 foot depth of medium grain sand in bed
2	1.4 foot depth of fine grain sand in bed
3	knickpoint: 9 foot wide x 2 foot deep channel with 1.4 foot depth of fine grain sand in bed
4	pond outfall
5	channel-spanning bed log
6	quarry-spall roughened bed beneath pedestrian bridge
7	inlet for stormwater pond
8	satuated ground surrounding sw pond

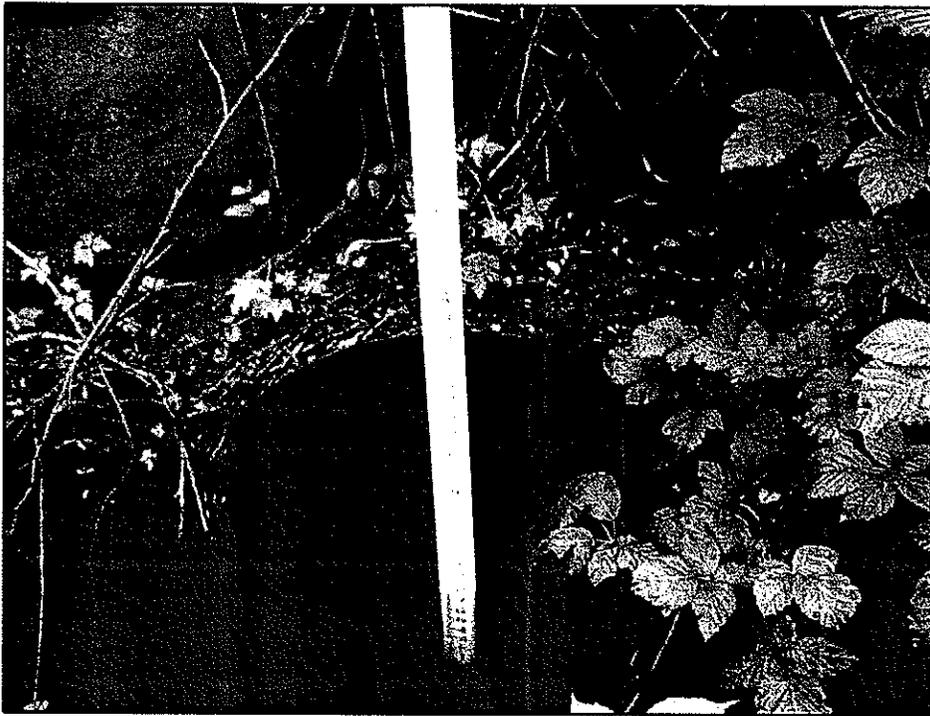
**Photo 1.** View of the 171<sup>st</sup> Avenue NE culvert outlet.

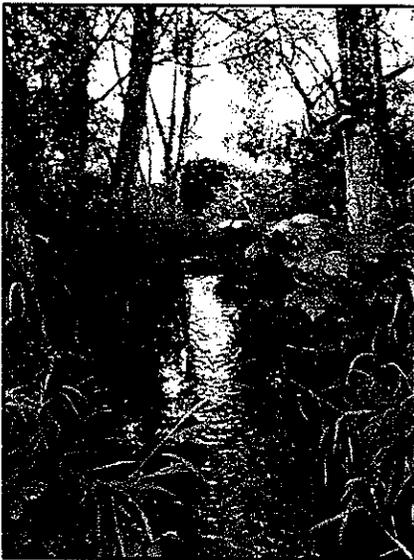
**Photo 2.** View of the looking downstream in the aggrading channel segment just downstream from the 131<sup>st</sup> Avenue NE culvert outfall.

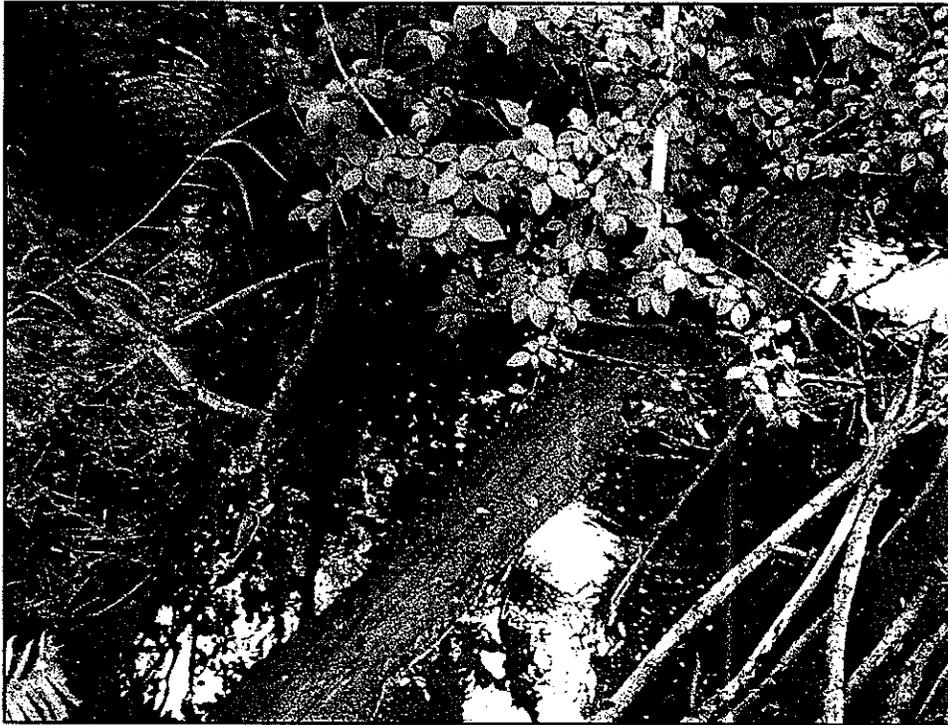
**Photo 4.** View from the left bank looking obliquely downstream of the large channel-spanning bed log that constitutes a fish-passage barrier.

We propose to improve the fish passage conditions in Woodin Creek and provide wetland enhancement mitigation in Woodin Creek Park. Improvement of fish passage conditions will be accomplished by eliminating the physical barrier that is formed by the channel-spanning bed log (Appendix C). This goal will be achieved by creating a low-flow notch in the log, and making minor channel improvements in the immediate vicinity. This alternative requires minimal use of heavy machinery and disturbance to the riparian zone of the stream. The low-flow notch alternative involves using gravel bags to divert flow around the work zone, excavating a small volume of sediment upstream from the channel-spanning log, attaching geotextile to the upstream end of log, and backfilling with stream gravel that would be transported to the channel in wheel barrows. A chain saw would be used to add a low-flow notch to the log to allow a lower energy drop in water surface elevation between the upper reach and the lower reach.

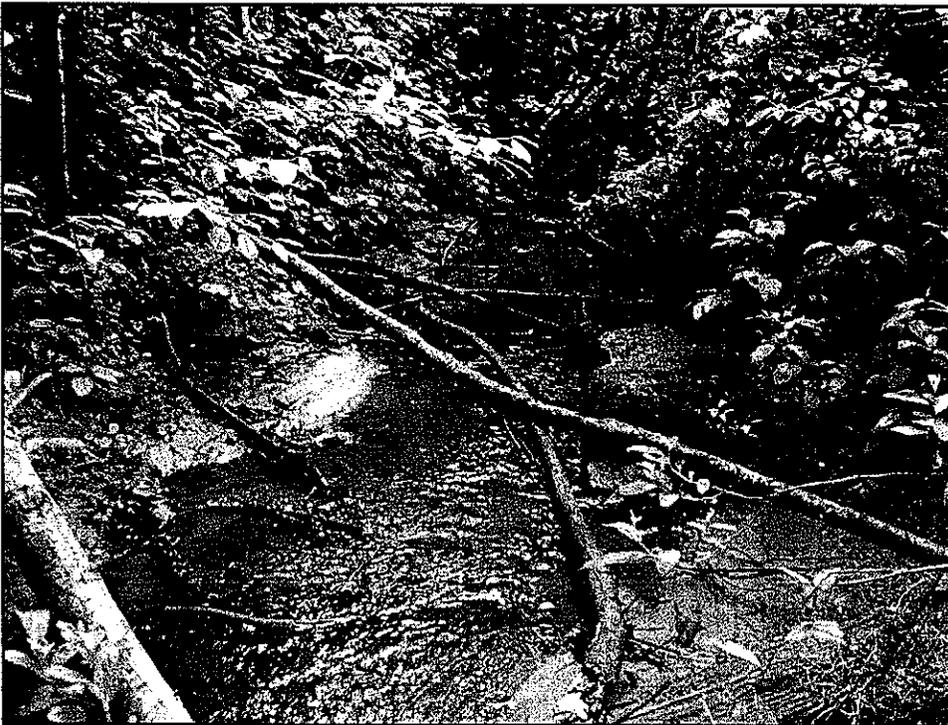
**Photo 5.** View looking downstream of the enlarged channel segment downstream from the stormwater pond outlet and channel-spanning bed log.

Approximately 450 feet downstream from the 131<sup>st</sup> Avenue NE culvert, Woodin Creek receives runoff from a surface water detention pond on its left bank (point 4). Flashy urban hydrology is the likely cause of substantial channel enlargement in the reach downstream from the pond outfall. Significant bed scour has occurred downstream from a large channel-spanning log that was probably originally installed as grade control for the pond outfall (point 5, photo 5). This log causes a vertical drop in water surface of one foot or more during low flow and therefore presents an impediment/partial barrier to fish migration. Downstream from this log the channel becomes wider; gravel is present in larger quantities on the bed and fines are more commonly found forming bars along the channel margins. Immediately upstream from the confluence with the Sammamish River, Woodin Creek flows under a pedestrian bridge associated with the Sammamish River Trail. The channel is roughened through this crossing with coarse quarry spalls and 1-man boulders (point 6, photo 6).

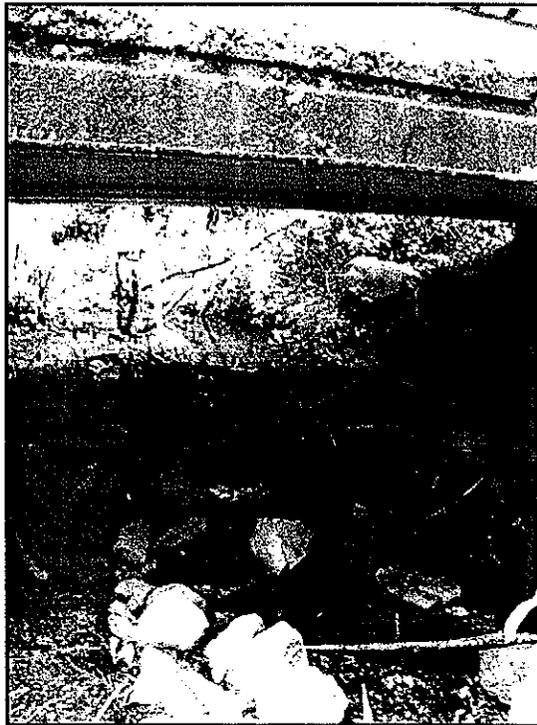
**Photo 6.** Roughened bed section below the Sammamish River Trail upstream from the Sammamish River confluence.

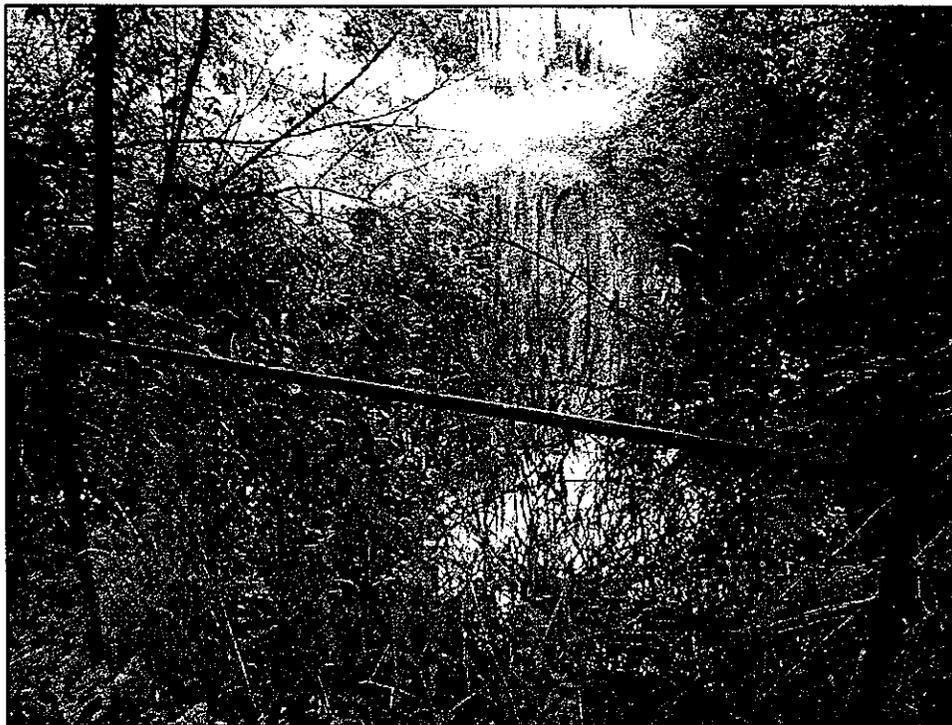
**Photo 7.** View of the stormwater pond from the parking lot at Waterford Place Apartments.

The stormwater pond on the left bank of Woodin Creek (points 7 and 8, photos 7 and 8) appears to collect storm water runoff from the Waterford Place Apartments located at 13305 NE 171<sup>st</sup> Street. In its current condition it is largely dead storage, having accumulated a large volume of fine sediment that has reduced its capacity to detain storm water. There is some evidence that overland flow originates from the pond during some large storm events and causes sheetwash erosion downstream from the pond. Matted vegetation and exposed non-adventitious roots at the base of at least two different tree species on the left bank top indicate a general lowering of the land surface, while a thin duff layer indicates that this erosion has not occurred recently.

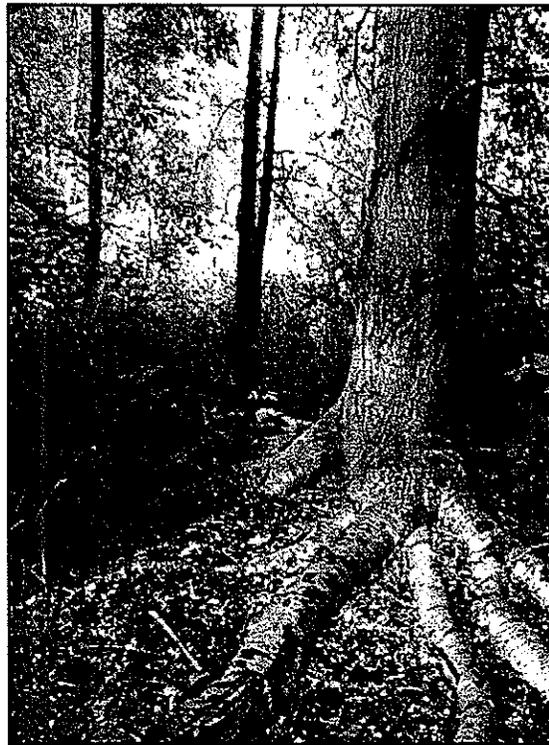
**Photo 8.** Potential evidence of intermittent sheet wash resulting from overland flow. Tree roots are exposed south of the stormwater pond on Woodin Creek left bank.

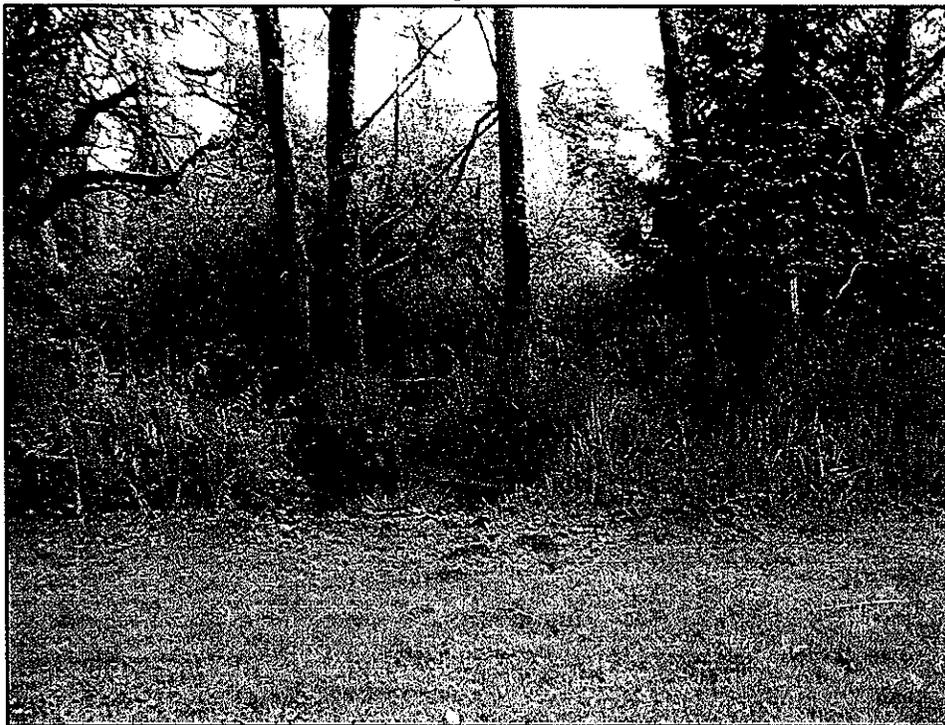
**Photo 9.** Potential mitigation site at Woodin Creek Park: looking east at Woodin Creek in an area where Himalayan blackberries were previously cleared.

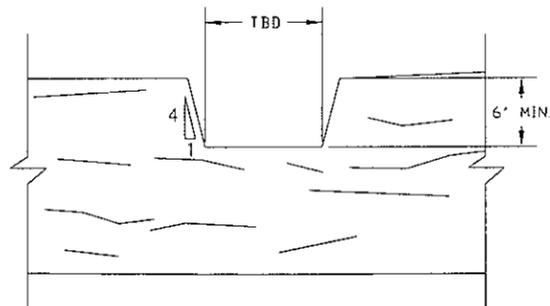
**LOW FLOW NOTCH DETAIL**  
NTS

NOTE: FINAL LOW-FLOW NOTCH DIMENSIONS TO BE DETERMINED BASED ON HYDROLOGIC MODELING RESULTS.
