Skagit Wetlands & Critical Areas

Wetland Delineation and Buffer Enhancement Plan

13215 NE 205th Street
Woodinville, WA 98072

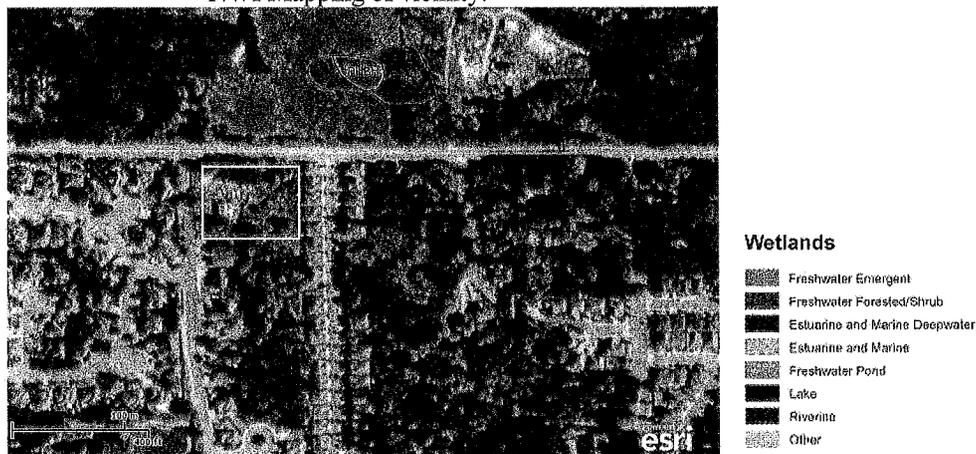
NWI Mapping of vicinity.

Subject property highlighted in yellow (general).

- Mapping put forth by the Washington State Department of Fish and Wildlife indicates no streams onsite.
- Washington State Department of Fish and Wildlife mapping indicates no documented use by salmonid fishes onsite or within the adjacent properties.
- Mapping as available from the Washington State Department of Fish and Wildlife Priority Habitat and Species Program indicates no Priority Species or habitats of such have primary association directly with this property.
- The National Wetland Inventory mapping shows no wetland presence onsite.

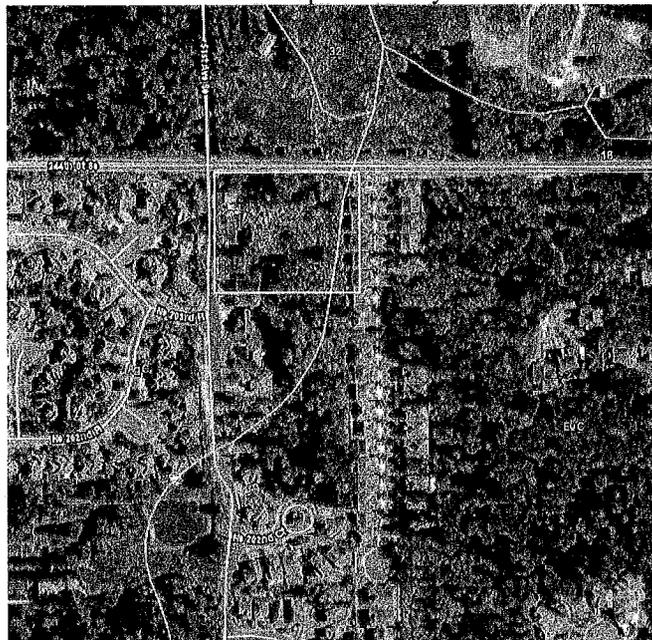
Soil Map of Vicinity

Subject area bound in yellow
AgB, AgC, #2-Alderwood gravelly sandy loam
EvC, #17, #18- Everett gravelly sandy loam

The *Soil Survey of King County Area, Washington* published by the U.S.D.A. Soil Conservation Service (now the N.R.C.S.) lists the dominating soils of this property as two separate soil series, Alderwood gravelly sandy loam as the majority soil, and Everett gravelly sandy loam throughout a sliver along the eastern boundary (see map, below). Distinct Everett soils were not observed.

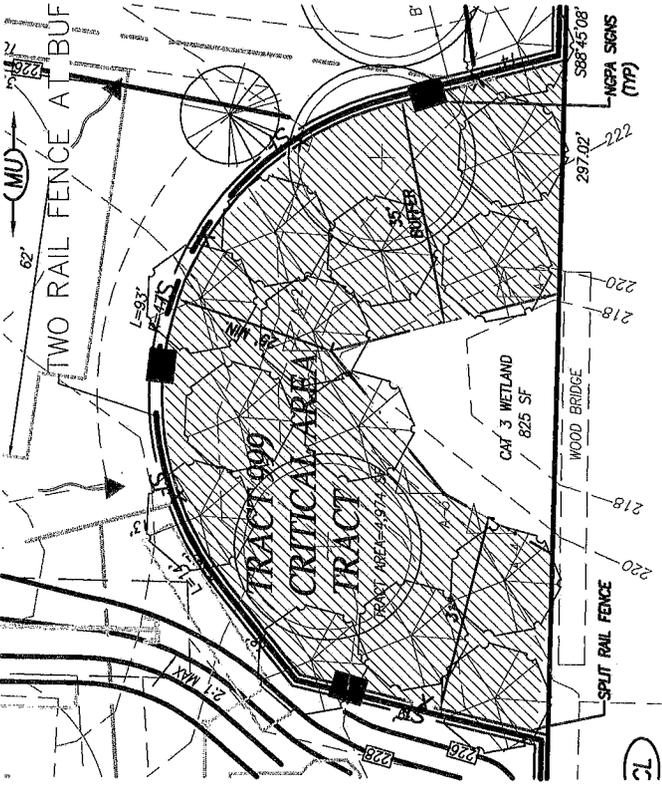
NW 1/4, SEC. 03, T. 26 N., R. 5 E., W.M.
WOODINVILLE 10
 DESIGNED BY: DATE: SCALE: JOB NO.:
 JRC 01-13-2016 1"=30' 15-0716
BUFFER ENHANCEMENT W2

BUFFER ENHANCEMENT PLANTINGS

TREE COUNT WITHIN BUFFER ENHANCEMENT AREA IS BASED ON AN AVERAGE SPACING OF 10 FEET ON CENTER, AND INCLUDES THE LARGE TREES PROPOSED WITHIN THE BUFFER AREA AS SHOWN ON THE PLAN.

SHRUB COUNT WITHIN BUFFER ENHANCEMENT AREA IS BASED ON AN AVERAGE SPACING OF 5 FEET ON CENTER, LESS THE TREES PLANTED WITHIN THE AREA. TOTAL SHRUB COUNT IS THEREFORE 123.

BLACKBERRY AND OTHER NOXIOUS NEEDS TO BE REMOVED PRIOR TO PLANTING PROVIDE 178 LINEAR FEET TWO RAIL FENCE AT EDGE OF BUFFER

As any usable native vegetation will be retained within the buffer as able, no detailed planting plan is specified (plan locations are approximate only), with numbers proposed based upon a density calculation. The density required when combined with the size of plant material is not what would typically be recommended, but is a requirement of the City of Woodinville. Shrub planting will utilize a 5-foot centers

density calculation and tree densities based upon a 10-ft center density calculation, with the layout specified by a well versed licensed landscape architect. While density calculations are given for a plant count, onsite constraints will place many of the shrubs and smaller trees at a much denser planting, making survivability, plant health, and ongoing maintenance for noxious weed control questionable. All tree and shrub plant costs supplied are plants in the ground, installation included. Often in an enhancement or restoration, plantings can be extrapolated precisely onto a drawn planting plan. In this case, like many others, however, there are still may be some relic native shrubs/trees within the area to be worked around. Utmost care will be taken to preserve these plants, but they were not mapped and will dictate the specific density and locations of plantings for the site. The plant schedule gives a total number and general locations, but density of plantings may vary throughout the site as conditions dictate, with plantings placed by an appropriate professional with consideration to wetland fringe and/or buffer location.
