City of Woodinville  
**Old Woodinville School House  
Feasibility/Renovation Study**

**Council Report**  
January 27, 2011

Existing Conditions Assessment  
October 23, 2009

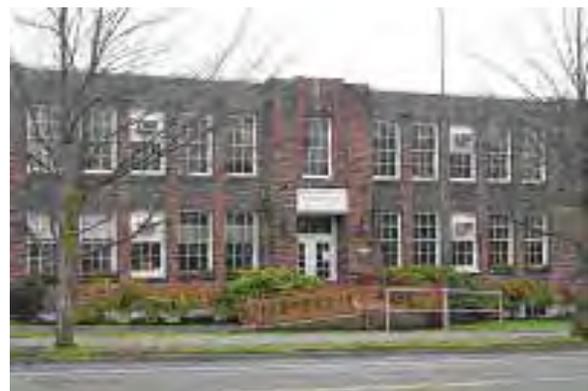
Fig A) North Elevation of Old Woodinville School House (The ramp in the photo has been removed.)

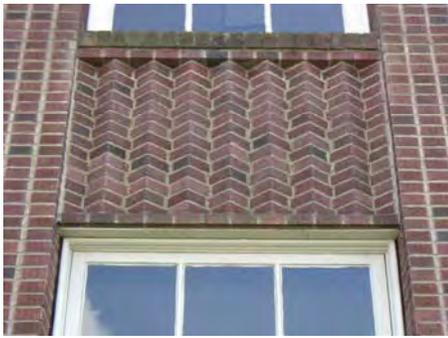
Fig B) Decorative brick on north elevation

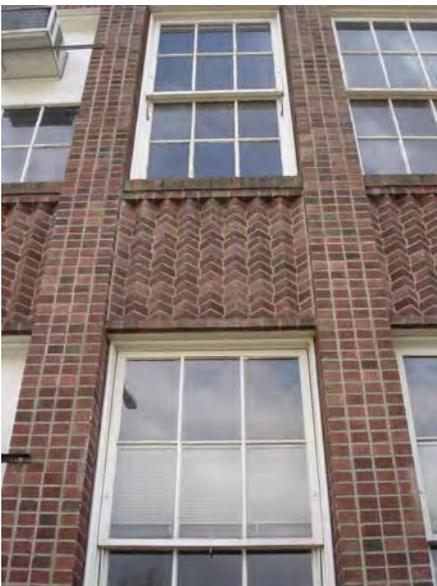
The original windows are wood-framed, single-glazed with true-divided lites and a unique double awning/hopper ventilating sash system. Windows in the basement on the south, north and west elevations are partially below-grade, opening onto lightwells. Some basement windows on the north elevation have been boarded over. Stairwell windows and the main/north entry doors include a fixed transom window above. Window-style air conditioning units were installed in the upper sashes of some of the windows on each elevation in the 1990's. The wood sash are in fair to average condition, with aged and some missing glazing putty and peeling paint. There are some areas of rot evident at the lower sash corners, especially on the south and west elevations. Reinforcing angle braces have been installed on the interior face of many lower sash units to hold the deteriorated corners together. The original wood subsills are currently exposed; few sills have any paint remaining and there is some surface rot evident, particularly on the south and west elevations. Original glazing is generally in good condition and mostly intact, although there are a few cracked glass units that have been sealed with tape. The glazing putty is generally in poor condition (to nonexistent) and should be repaired and/or replaced, if windows are preserved rather than replaced with new. Operable sash hardware appeared to be intact and potentially restorable at most windows, although not all are in working condition.

Fig F) Typical hopper/awning windows

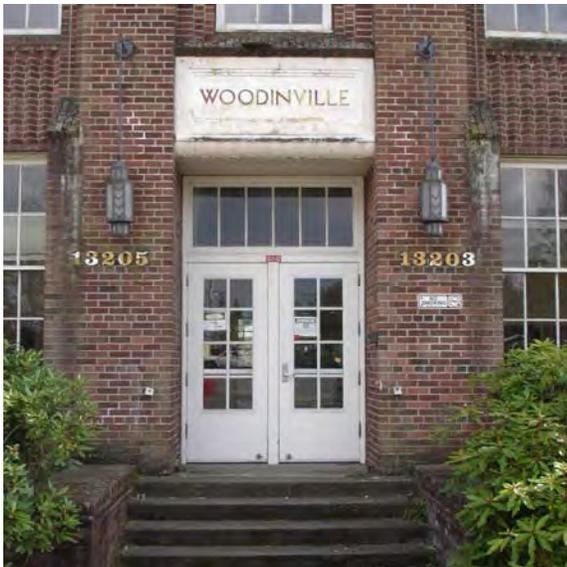
Two light fixtures flanking the north/main entry and appear to be of historic vintage from 1936. It was not ascertained if they are in working condition. Newer security/flood lights have been installed on the east, west and south elevations at the parapet level.

Fig G) Formal (north) entry with historic light fixtures

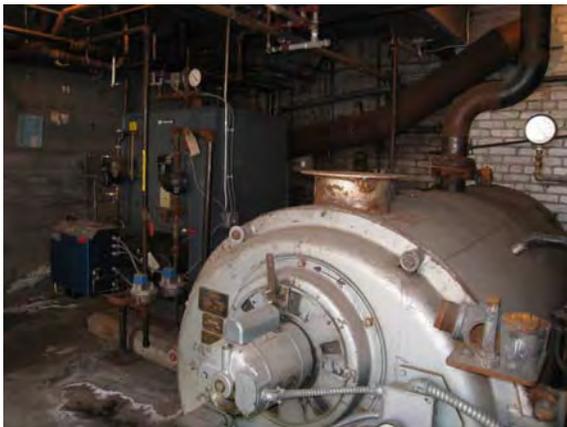
Fig H) Boiler in Basement

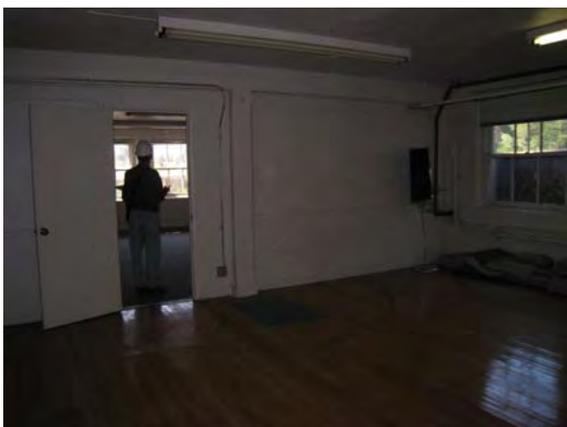
Floor finishes in the basement include linoleum, wood on 2" sleepers and direct-glue carpet. The linoleum floors and carpet are in very poor condition, with evidence of water staining. The raised wood floor is in fair condition, with some bowing visible.

Fig H) Basement classroom with wood flooring

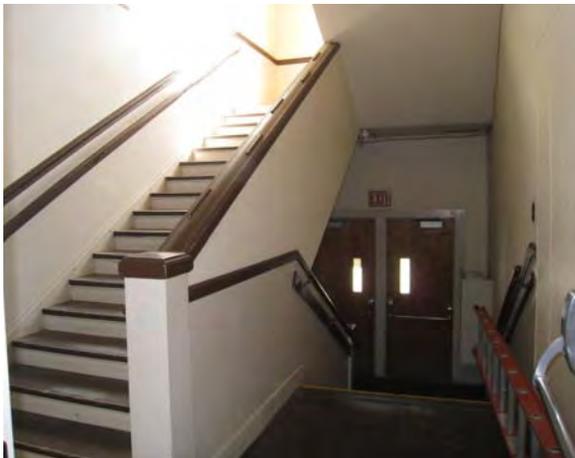
The concrete stairs to the basement are 56" wide with 6" risers and 11.25" treads, which comply with current code requirements. Stair treads and risers from the entry levels up are wood. The handrails are the original round wood grips and are in fair condition, although bracket attachments are not entirely secure throughout. The originally open stairwells have been enclosed with wood stud and gwb walls and hollow metal fire doors and closers at each floor level and appear to be code compliant with 1 hour rated exit enclosures.

Fig J) Typical stairwell

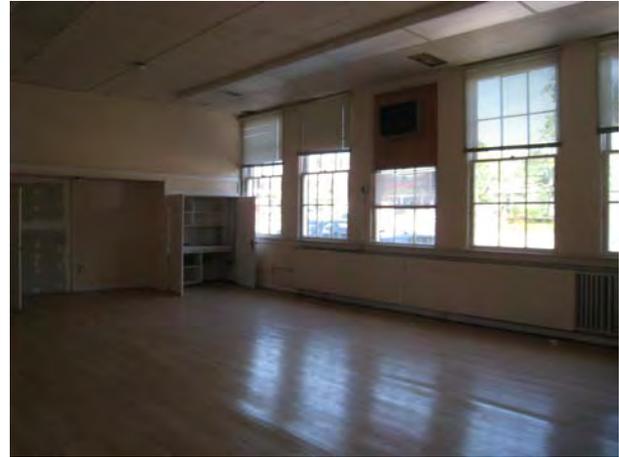
Fig M) Typical classroom

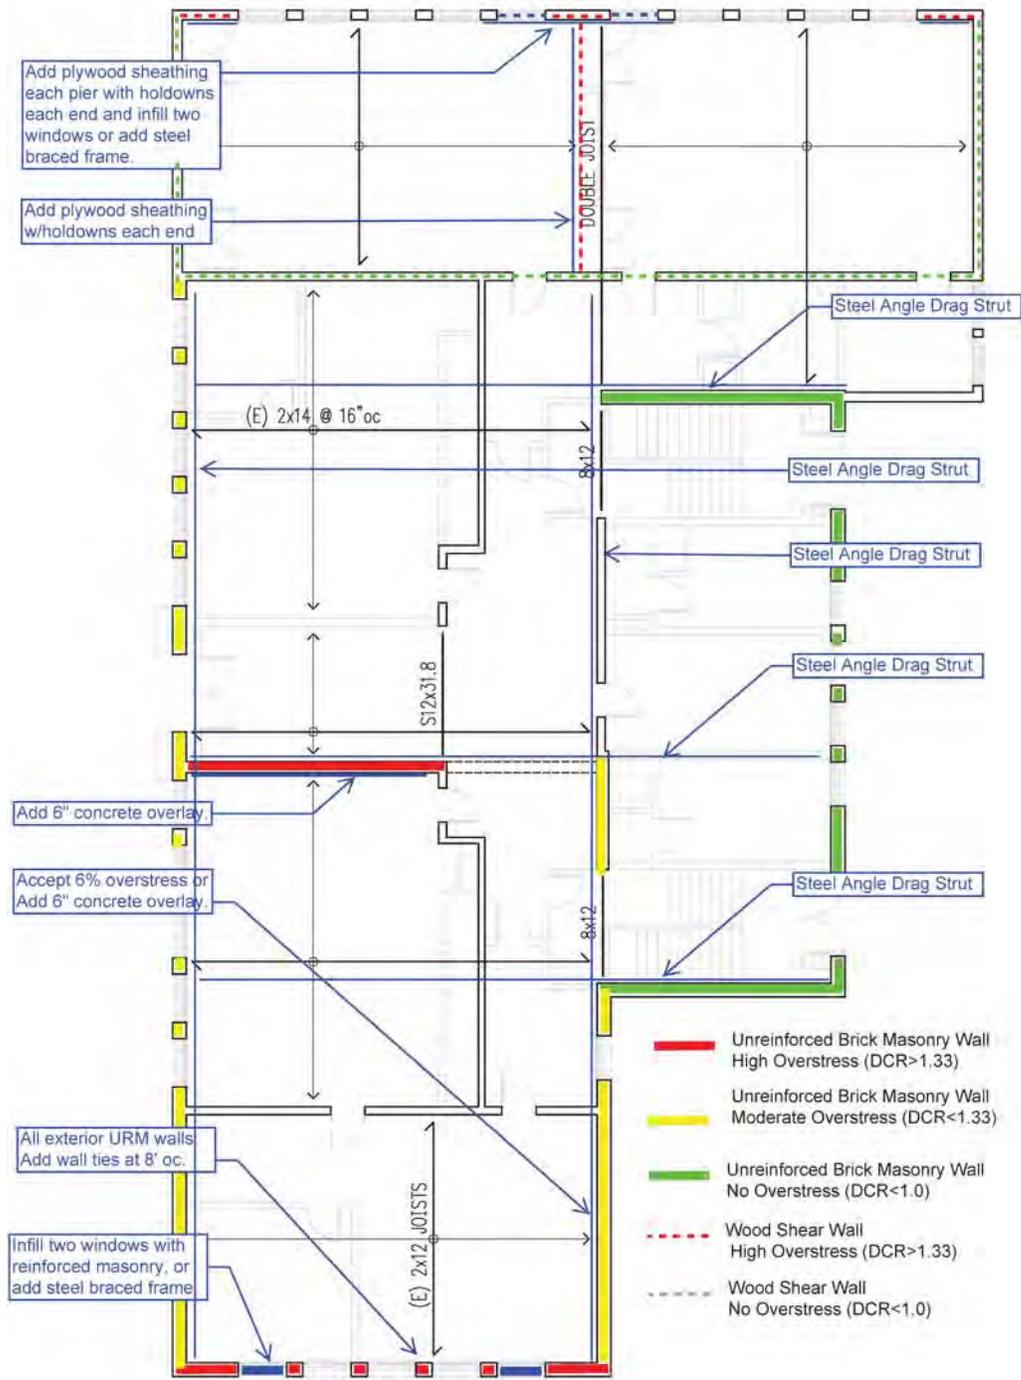
*Figure 2 –Second Floor Evaluation and Rehabilitation*

*Shear Wall Findings:* At the second floor, the exterior masonry walls were generally found compliant as illustrated in Figure 1. The exception is the masonry wall that forms the west wall of the main entry. According to our calculations, this wall is overstressed by approximately 15%. This same wall at the first floor is significantly overstressed at 35%. In addition, the west wall of the building was found 100% overstressed and moderate overstresses ranging from 6% to 17% were found in the north and south walls.

*Recommendations:* We recommend adding drag struts at the roof and second floor level at the location shown on Figures 1 and 2. Drag struts are required to provide a complete load path for earthquake forces.
